Intel[®] Xeon[®] Processor 7400 Series

Specification Update

| December 2010

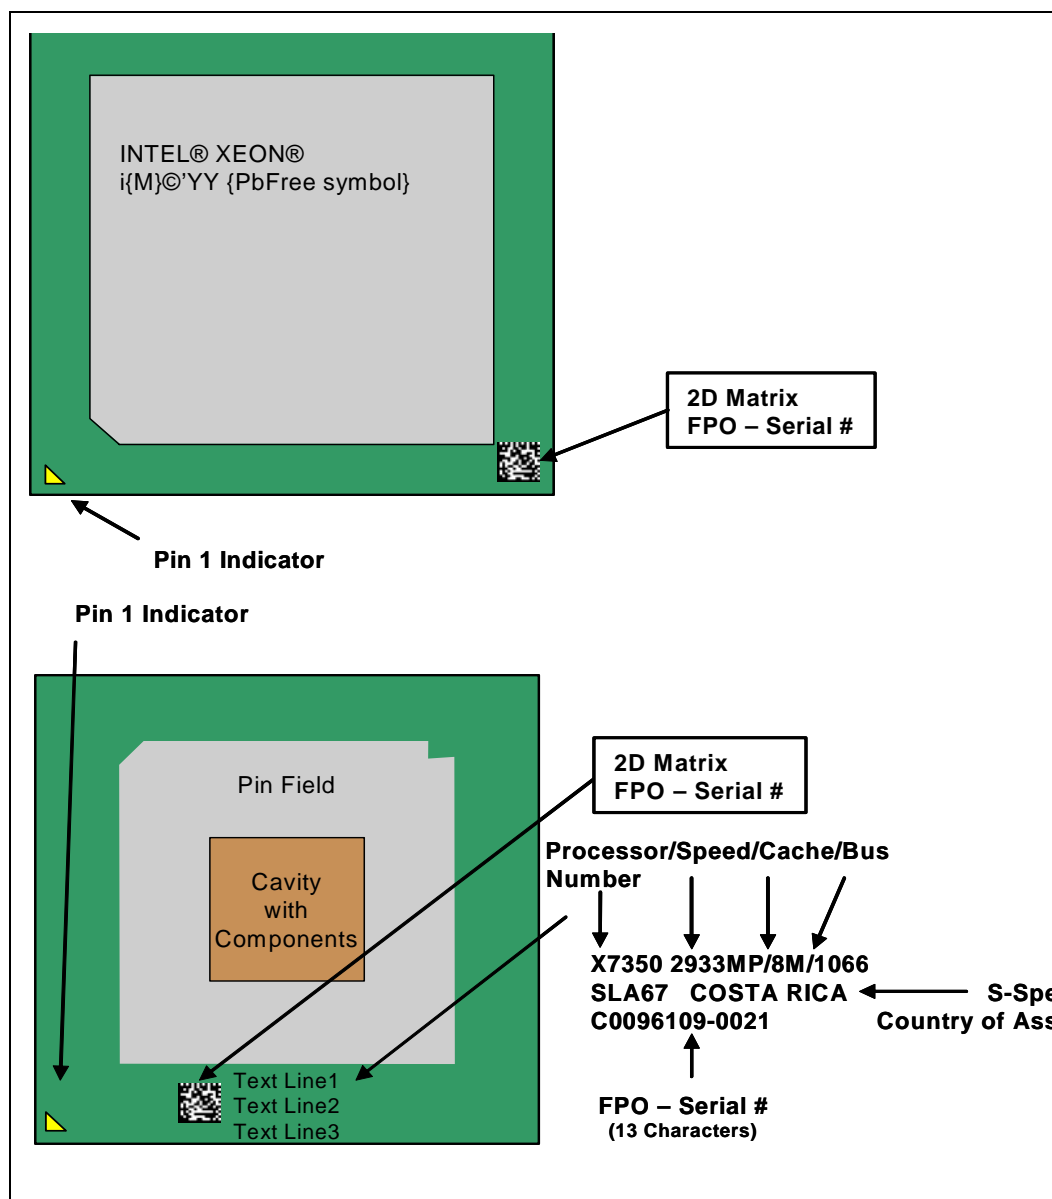
Figure 1. Processor Topside and Bottomside Markings (Example)

Intel® Xeon® Processor 7400 Series Package Markings

- Notes:**
1. All characters will be in upper case.
 2. Drawing is not to scale
