# Intel<sup>®</sup> Xeon<sup>®</sup> Processor 3400 Series

Specification Update

*November 2009*

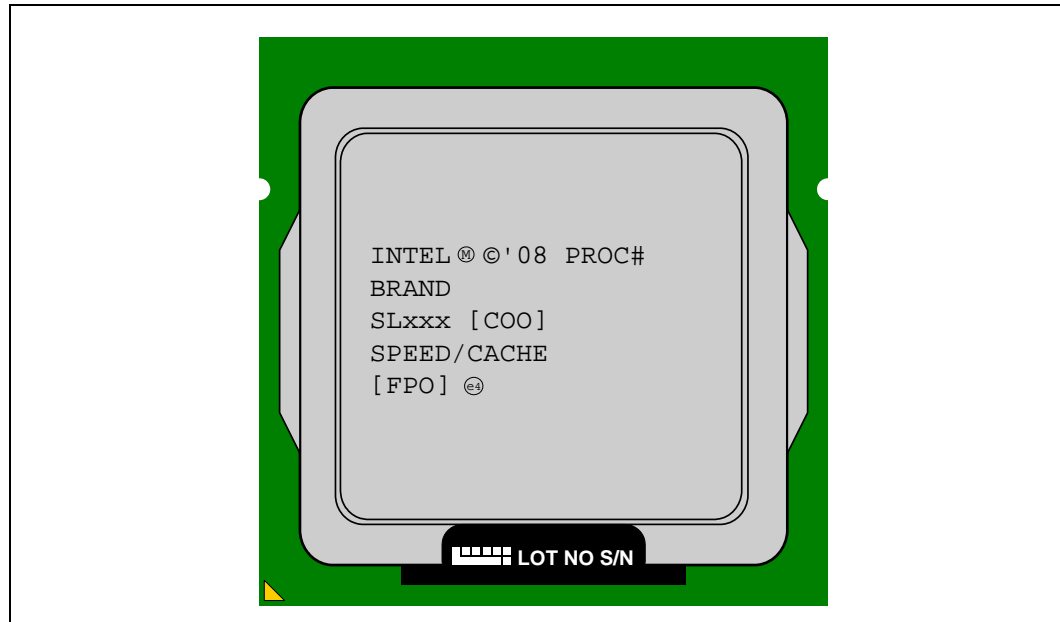
**Figure 1. Processor Production Top-side Markings (Example)**

The processor stepping can be identified by the following component markings.
