Intel[®] I/O Controller Hub 10 (ICH10) Family

Specification Update

| Document Number: 319974-008

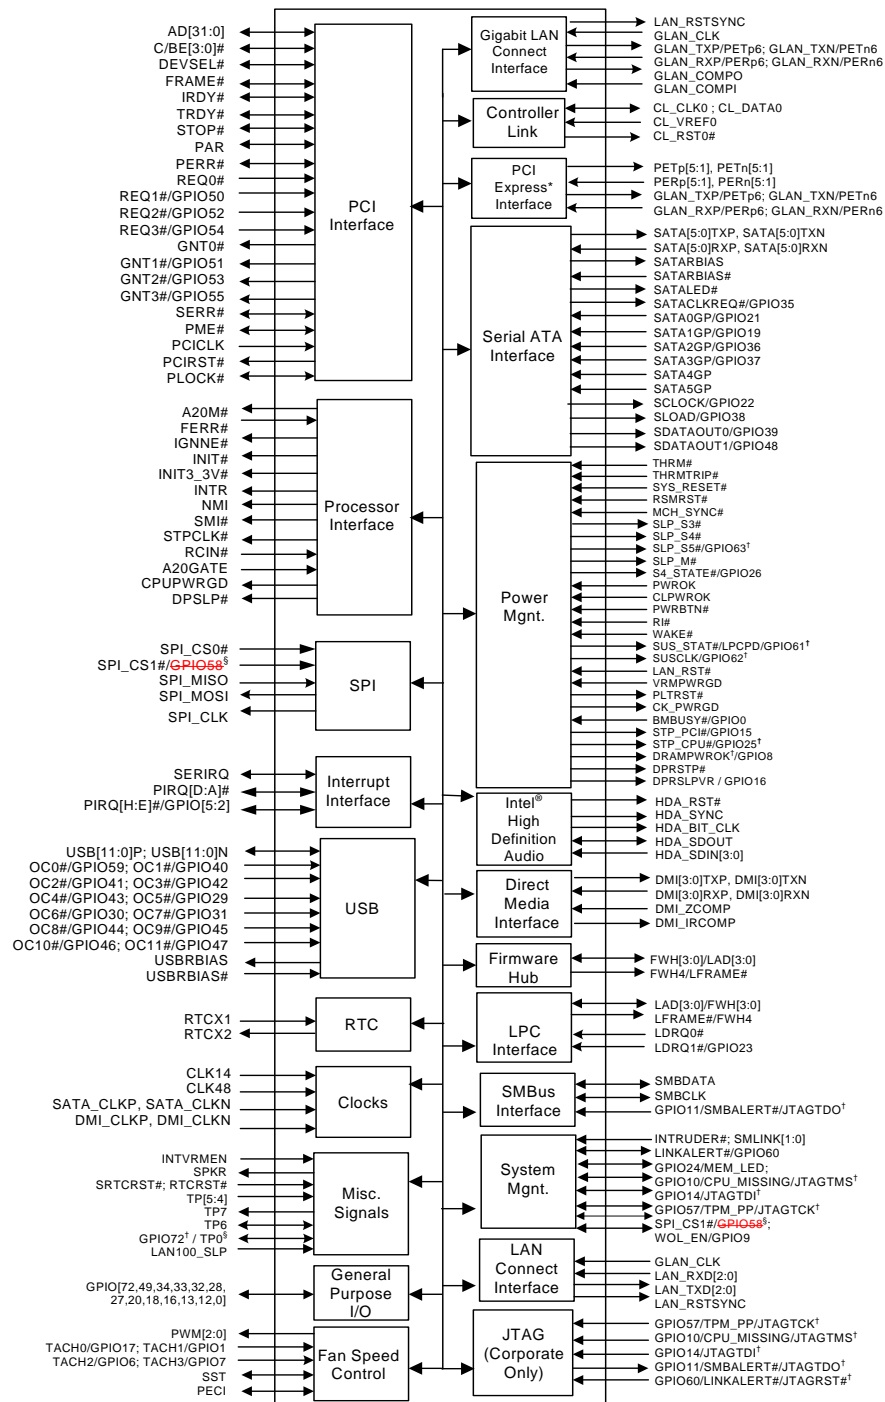
9. Remove GPIO58 from Figure 2-1 Intel® ICH10 Interface Signals Block Diagram

Update the following block diagram in Section 2 Signal Description in the Datasheet.

-006	Added Items: <ul style="list-style-type: none"> Corrected Device ID for D30:F0 in Table 2-27 ICH10 Consumer Device and Rev ID Table Document Changes: <ul style="list-style-type: none"> 9- Remove GPIO58 from Figure 2-1 Intel® ICH10 Interface Signals Block Diagram. 10- Add 1.1v for VccDMI in Table 2-24. 11-Correct Bit Types for PCI Express UnCorrectable Error Severity register (UEV) Corporate ICH10. 12- Correct PCI Express DSTS register definition for bit 1 (NFED) 	April 2009
-007	Added Items: <ul style="list-style-type: none"> Errata: 13- Intel® I/O Controller Hub 10 (ICH10) Family SATA Low Power Device Detection Document Changes: <ul style="list-style-type: none"> 13 -Correct SMBCLK_CTL bit default value 14 - Correct Table 2-24 Strap selection for Boot BIOS Destination 	July 2009
-008	Added Items: <ul style="list-style-type: none"> Errata: 14- Intel® I/O Controller Hub 10 (ICH10) Family PCI Express Function Disable Document Changes: <ul style="list-style-type: none"> 15- Correct section 5.13.6.5 Sx-G3-Sx, Handling Power Failures regarding wake events following a power failure 	August 2009

No.	DOCUMENTATION CHANGES
5	Update GPIO Note #4 in Section 3.2 Output and I/O Signals Planes and States
6	Make correction to Table 5-40 Causes of Host and Global Resets
7	Update bit definition for SECOND_TO_STS
8	Add foot note for all references to SPI Flash descriptors ICHSTRP0 and MCHSTRP0
9	Remove GPIO58 from Figure 2-1 Intel® ICH10 Interface Signals Block Diagram
10	Add 1.1v for VccDMI in Table 2-24
11	Correct Bit Types for PCI Express UnCorrectable Error Severity register (UEV) Corporate ICH10
12	Correct PCI Express DSTS register definition for bit 1 (NFED).
13	Correct SMBCLK_CTL bit default value
14	Correct Table 2-24 Strap selection for Boot BIOS Destination
15	Correct section 5.13.6.5 Sx-G3-Sx regarding possible wake events following a power failure
