# Intel<sup>®</sup> 5520 and Intel<sup>®</sup> 5500 Chipset

## Specification Update

| *September 2011*

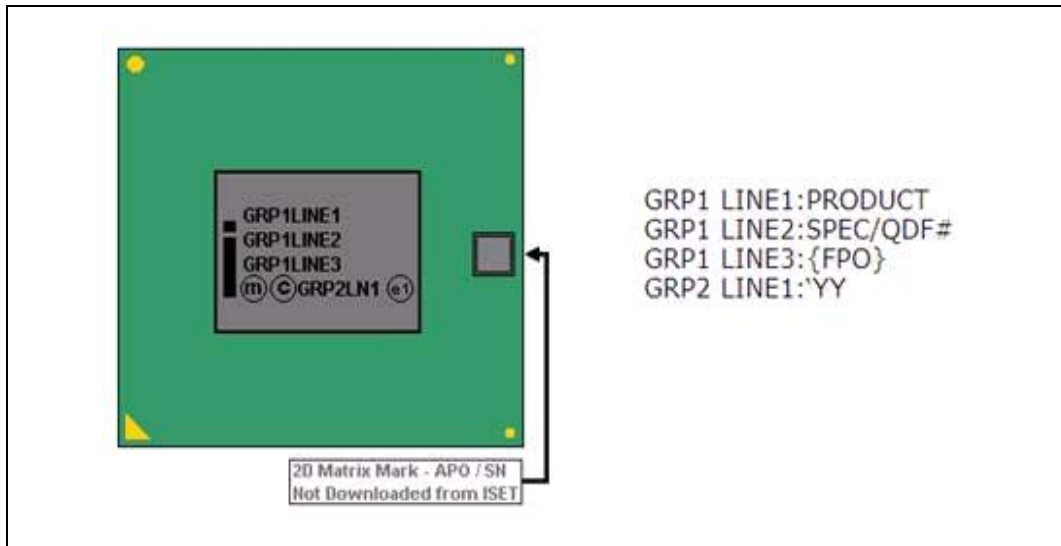
Figure 1. Top-Side Marking Example

1. This is an Engineering Sample
2. This is a Production part
3. This part has 24 PCIe\* lanes
4. This part has 36 PCIe lanes
5. This part supports Intel® Trusted Execution Technology (Intel® TXT)
