Intel[®] 7300 Chipset Memory Controller Hub (MCH)

Specification Update

| *October 2009*

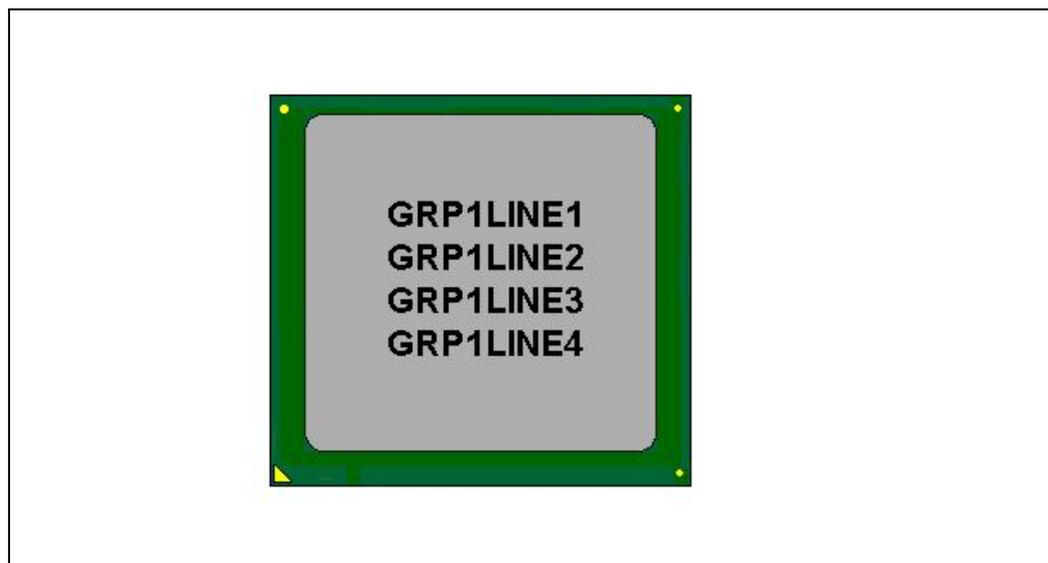
Figure 1. Top-Side Marking Example

Stepping	QDF-Spec	Top Marking	Notes
A-1	SLAGJ	QG7300	Production
