Intel[®] 7500 Chipset

Specification Update

October 2011

Reference Number: 323168-009

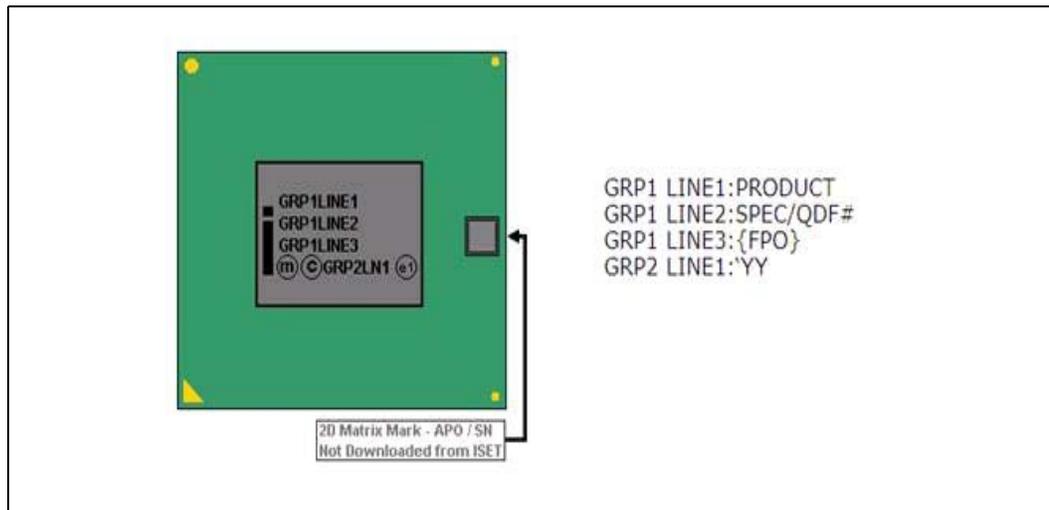
Figure 1. Top Side Marking Example

Stepping	LS-spec	Top Marking	Notes
B2	SLH3K	AC7500BXB	Production
