# Intel<sup>®</sup> 82573 Family Gigabit Ethernet Controllers Specification Update

*Networking Silicon*

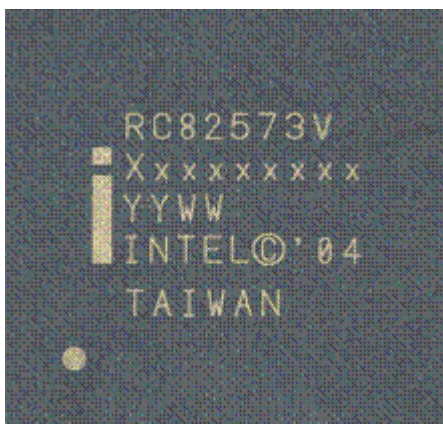
**Leaded Version**

#### Production Unit Mark Diagrams

**Table 3 Production Marks (“RC” Prefix Leaded Parts)**
