# **Intel® Atom™ Processor N2000 and D2000 Series**

## **Specification Update**

***March 2013***

***Revision 012***

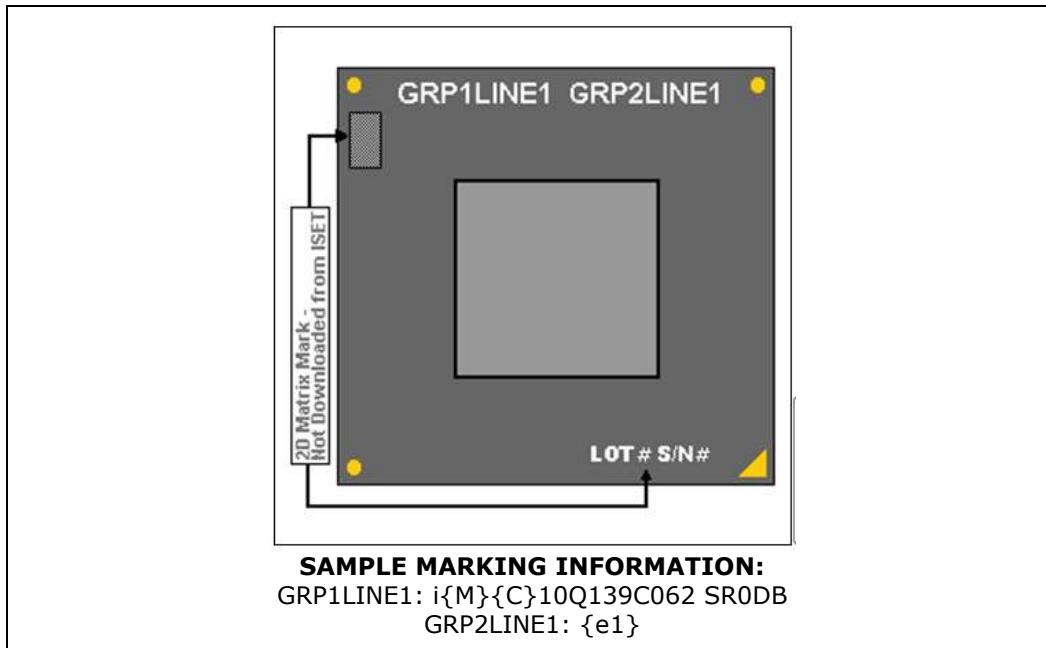
**Figure 1: Intel® Atom™ Processor N2000 and D2000 Series (Micro-FCBGA11) Markings**

Intel® Atom™ Processor N2000 and D2000 series is identified by the following component markings.

Revision	Description	Date
001	<ul style="list-style-type: none"><li>Initial Release</li></ul>	September 2011
002	<ul style="list-style-type: none"><li>Updated Figure 1 Marking detail</li><li>Added errata BQ5 to BQ10</li></ul>	November 2011
003	<ul style="list-style-type: none"><li>Added errata BQ11, BQ12, BQ13 and BQ14</li></ul>	November 2011
004	<ul style="list-style-type: none"><li>Added N2000 series to title, content and Table 2.</li><li>Added errata BQ15 and BQ16</li><li>Corrected implication lost in previous version</li></ul>	December 2011
005	<ul style="list-style-type: none"><li>Updated Table 2 for new SKU information</li><li>Updated new errata—BQ17</li></ul>	January 2012
006	<ul style="list-style-type: none"><li>Updated Table 2 for new SKU information</li><li>Updated new errata—BQ18 and BQ19</li></ul>	February 2012
007	<ul style="list-style-type: none"><li>Updated Table 2 for new SKU information</li><li>Added new errata—<a href="#">BQ20</a> and <a href="#">BQ21</a></li></ul>	March 2012
