**Intel<sup>®</sup> Core<sup>™</sup>2 Extreme Quad-Core Mobile Processor,  
Intel<sup>®</sup> Core<sup>™</sup>2 Quad Mobile Processor,  
Intel<sup>®</sup> Core<sup>™</sup>2 Extreme Mobile Processor,  
Intel<sup>®</sup> Core<sup>™</sup>2 Duo Mobile Processor,  
Intel<sup>®</sup> Core<sup>™</sup>2 Solo Mobile Processor and  
Intel<sup>®</sup> Celeron<sup>®</sup> Processor  
on 45-nm Process**

**Specification Update**

*December 2010*

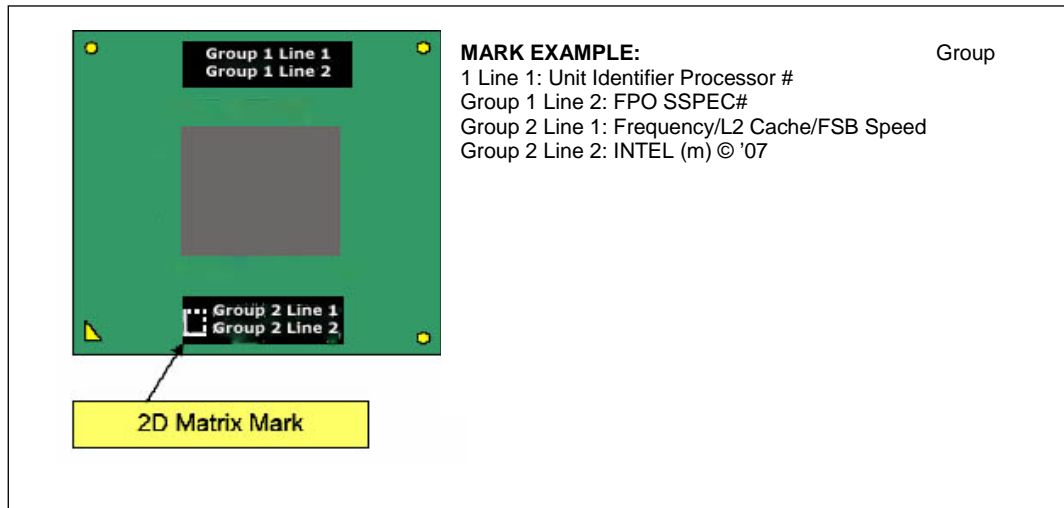
Figure 1. Processor S-Spec Top-side Markings (Example)

The processor stepping can be identified by the following component markings:
