Intel[®] E8500 Chipset North Bridge (NB)

Specification Update

Document Number: **306747-002**

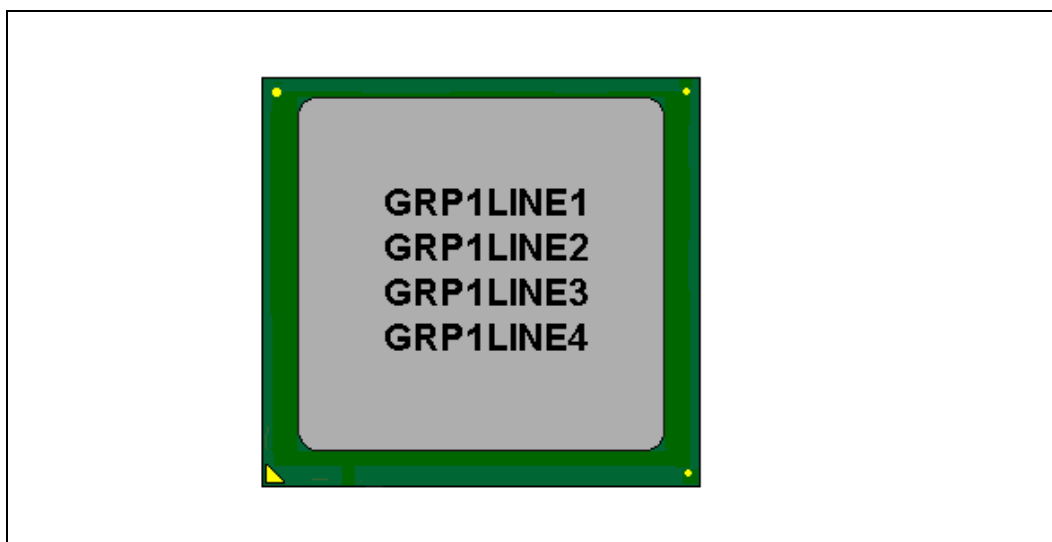
Figure 1. Top-Side Marking Example (optional)

Stepping	QDF-Spec	S-Spec	Top Marking	Notes
B0	QE34ES	N/A	NQ84001TNB	
B0	QG54	N/A	QG84001TNB	Lead free package
