Mobile Intel® 915GM/PM/GME/GMS and 910GML/GMLE Express Chipset

Specification Update

April 2007

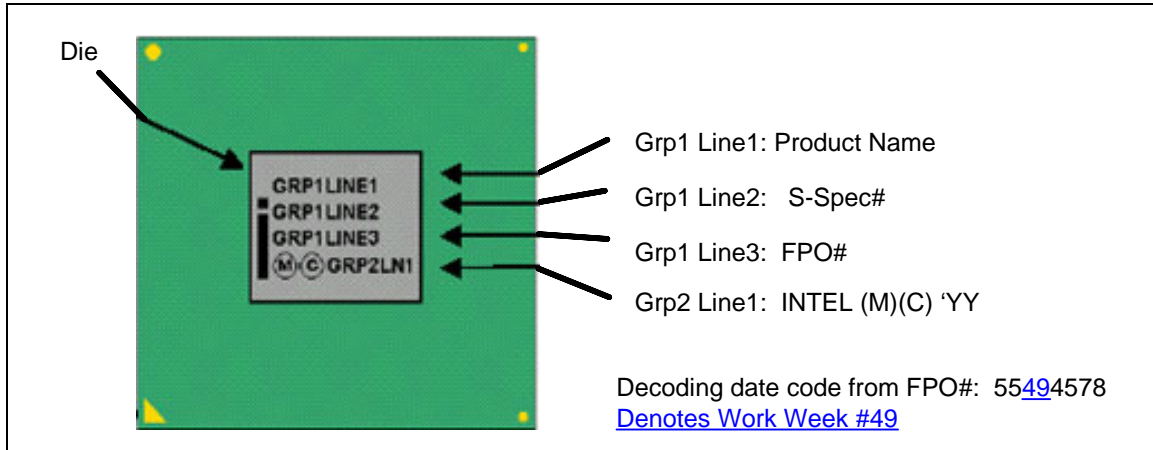
Figure 1. Mobile 915PM/GM/GMS/GME & 910GML/GMLE Express Chipset Package Markings
