Intel[®] X58 Express Chipset

Specification Update

May 2010

Doc Number: 320839-013

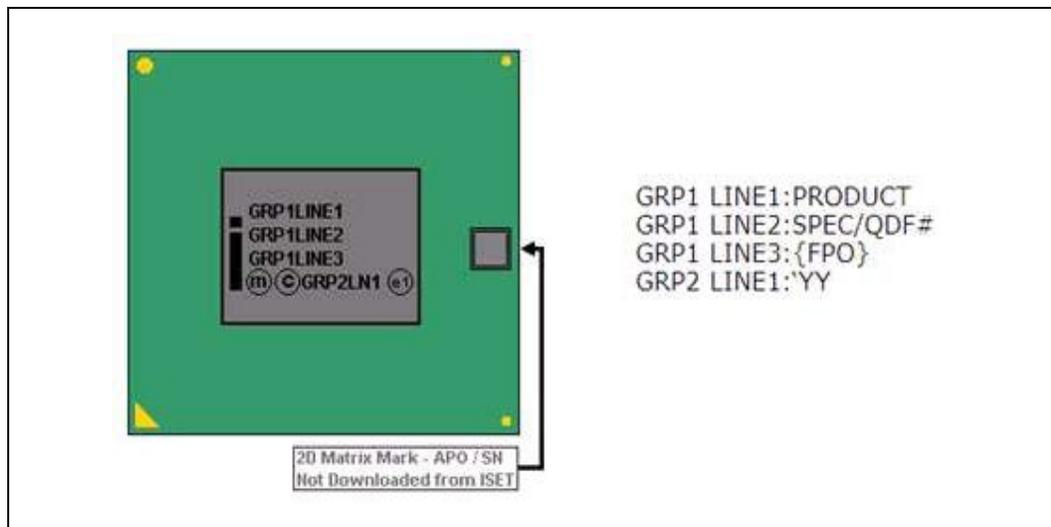
Figure 1. Top-Side Marking Example

Stepping	S-Spec	Top Marking	Notes
B2	SLGBT	AC82X58	Production Units
B3	SLGMX	AC82X58 SLGMX 901076	Production Units
C2	SLH3M	AC82X58 SLH3M 904727	Production Units
