Intel[®] Xeon[®] Processor MP

Specification Update

October 2005

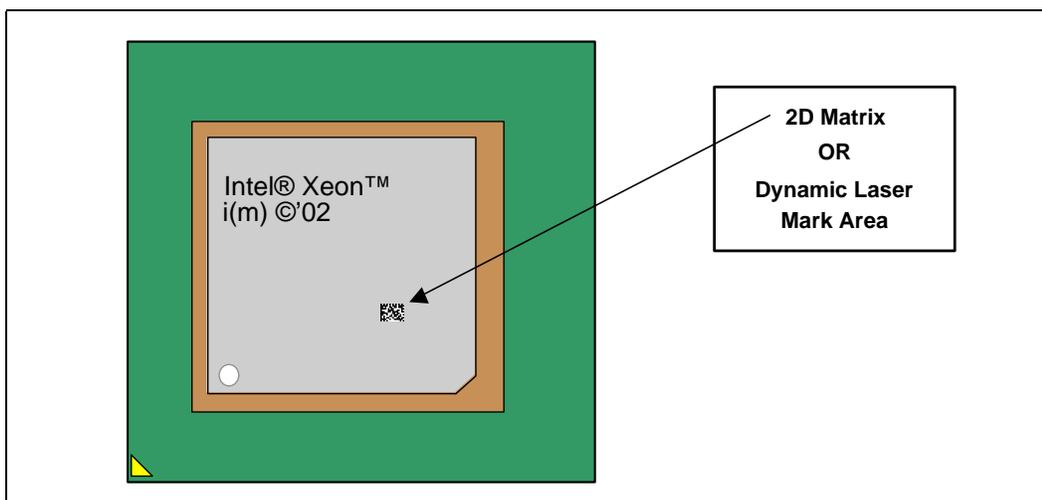
Figure 1. Top Side Processor Marking – Production Part

Intel® Xeon® Processor MP and Intel® Xeon® Processor MP with up to 4MB L3 Cache (on 0.13 Micron Process) Markings (603-pin INT-mPGA)

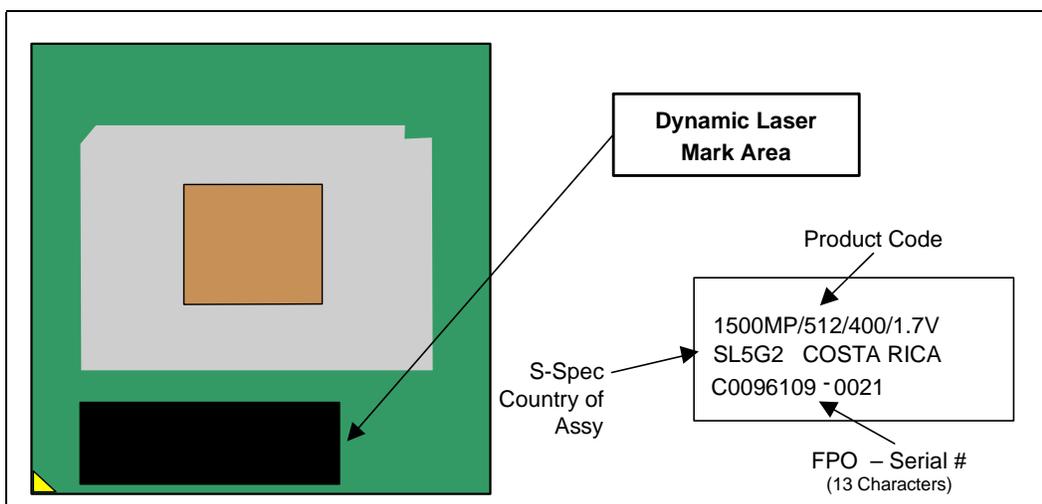
Figure 2. Bottom Side Processor Marking
