# 64-bit Intel® Xeon® Processor with 800 MHz System Bus (1 MB and 2 MB L2 Cache Versions)

## Specification Update

Document Number: 302402-022

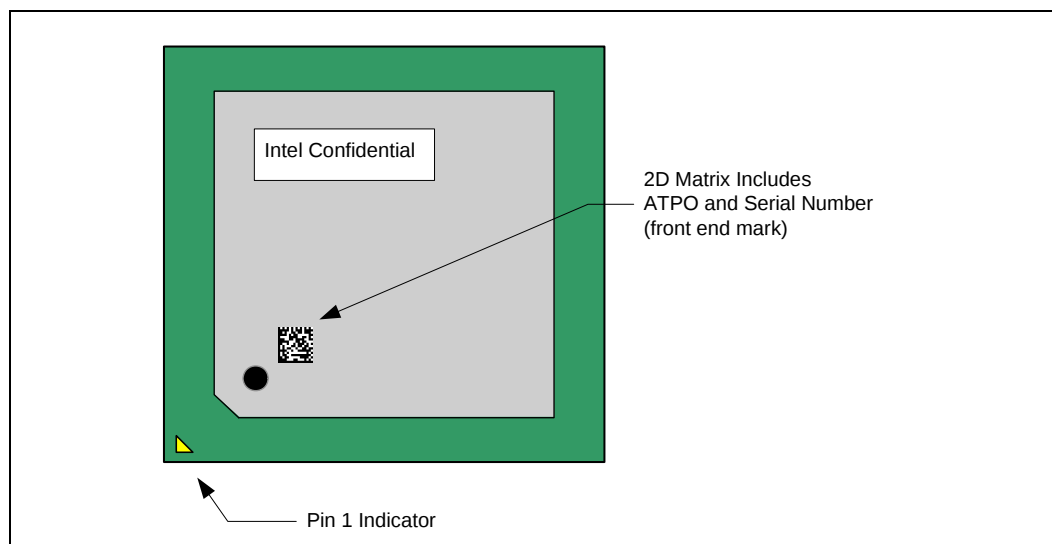
### 64-bit Intel® Xeon® Processor with 800 MHz System Bus (1 MB and 2 MB L2 Cache Versions) Package Markings (604-pin FC-mPGA4 Package)

Figure 1. Top-Side Processor Marking Example

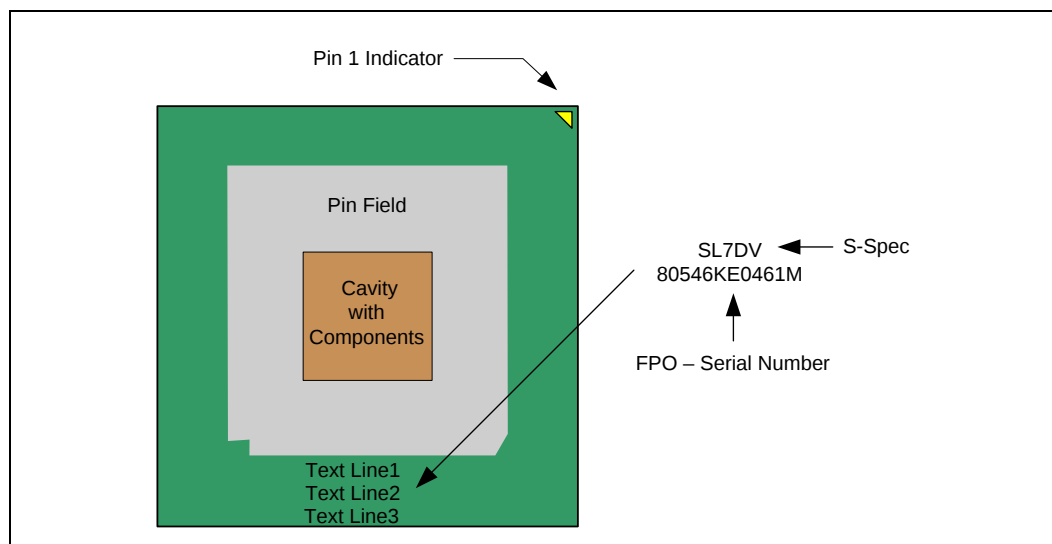
Figure 2. Bottom-Side Marking Example
