# Intel<sup>®</sup> 82576EB Gigabit Ethernet Controller Specification Update

Networking Division (ND)

Revision 3.0  
August 2015

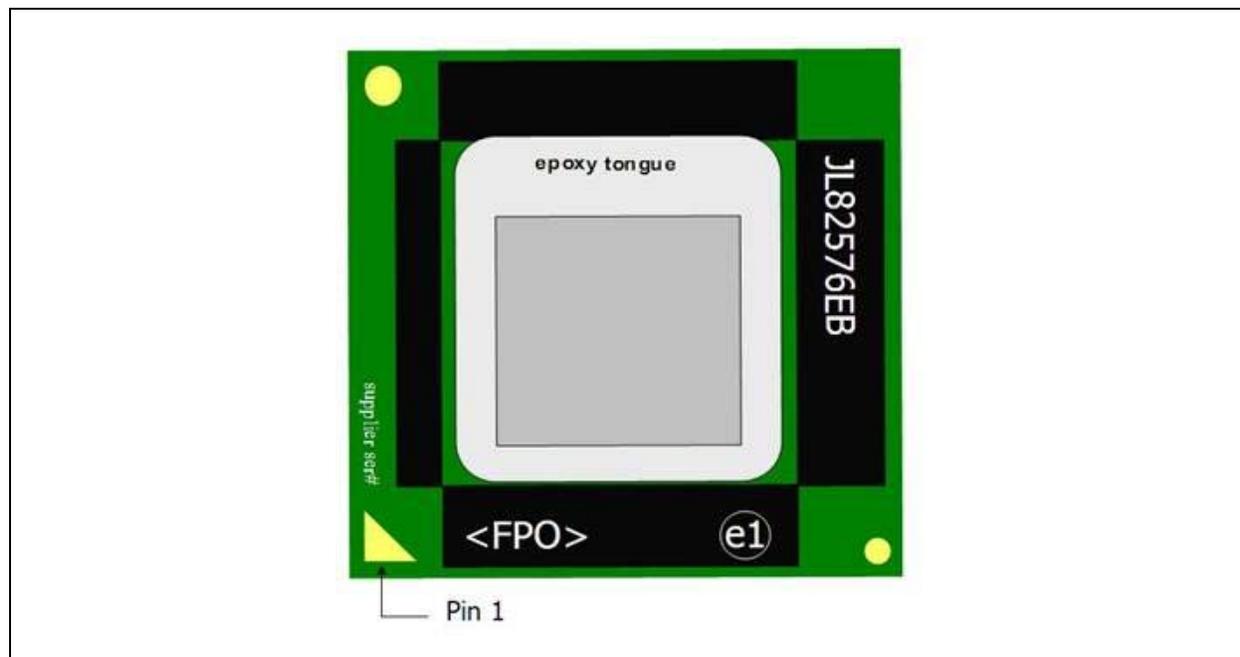
### 1.30 Marking Diagram

Figure 1. Example With Identifying Marks

Lead-free parts will have “JL” as the prefix for the product code (vs. “HL”).
