# Intel® Atom™ Processor N270 Series

Specification Update

*August 2009*

*Revision 005*

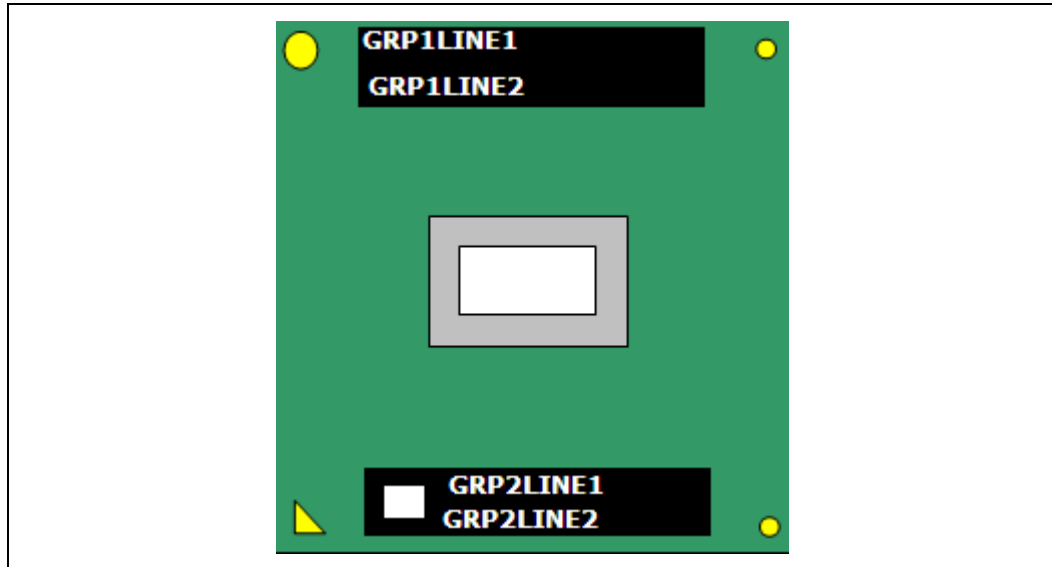
Figure 1. Mobile Intel® Atom™ Processor N270 Series (FCBGA8) Markings

Mobile Intel® Atom™ processor N270 series is identified by the following component markings.
