Intel® C102/C104 and C112/C114 Scalable Memory Buffer

Specification Update

April 2017

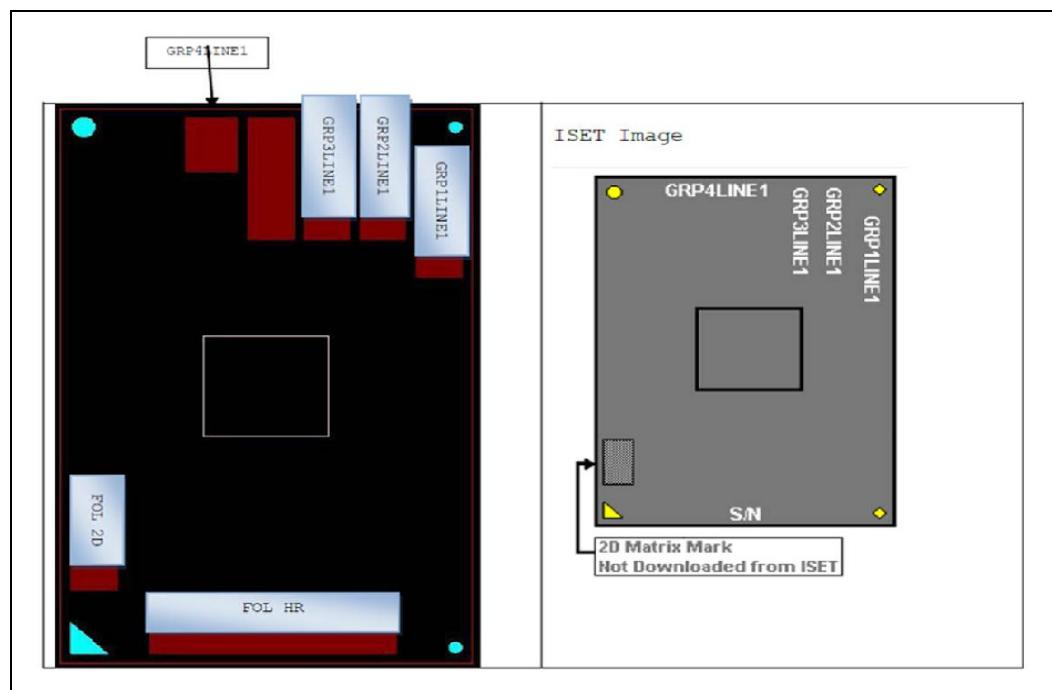
Figure 1. Intel® C102/C104 and C112/C114 Scalable Memory Buffer Markings

SKU	GRP1LINE1	GRP2LINE1	GRP3LINE1	GRP4LINE1
Intel® C112	date code in the form of i{M}{C}YY	FPO	SLKHU	{eX}
Intel® C114	date code in the form of i{M}{C}YY	FPO	SLKHV	{eX}

1. Pin 1 orientation is in the lower left corner.
