Intel[®] Pentium[®] 4 Processor 6x1^Δ Sequence

Specification Update

– On 65 nm Process in the 775-land LGA Package, supporting Hyper-Threading Technology and Intel[®] Extended Memory 64 Technology

June 2008

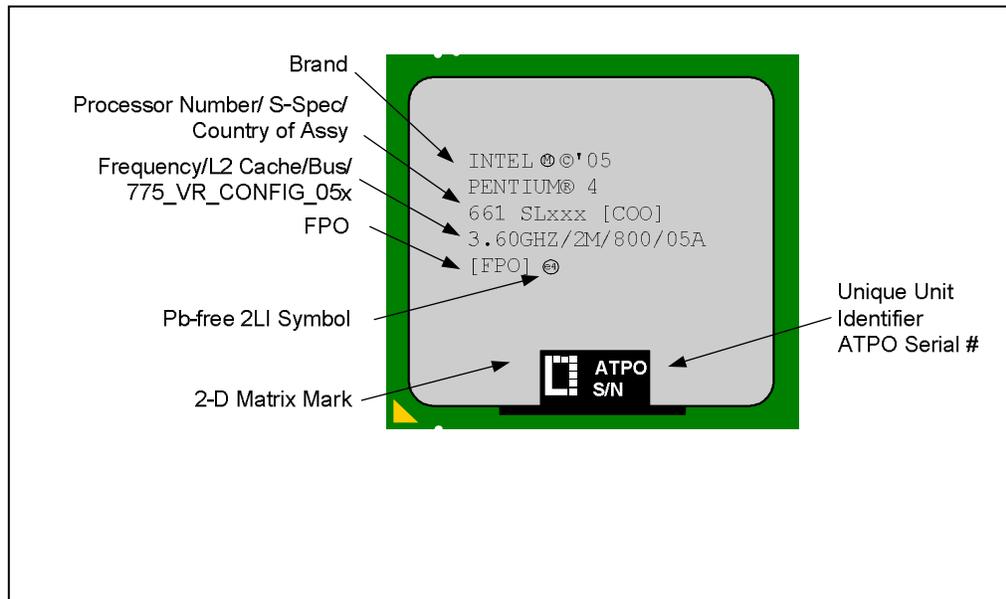
Figure 1. Intel® Pentium® 4 Processor 6x1 Sequence Package supporting 775_VR_CONFIG_05A Specifications (Top Markings)
