Mobile Intel[®] Pentium[®] 4 Processor with 533 MHz System Bus

Specification Update

January 2006

Document Number: [253176-022](#)

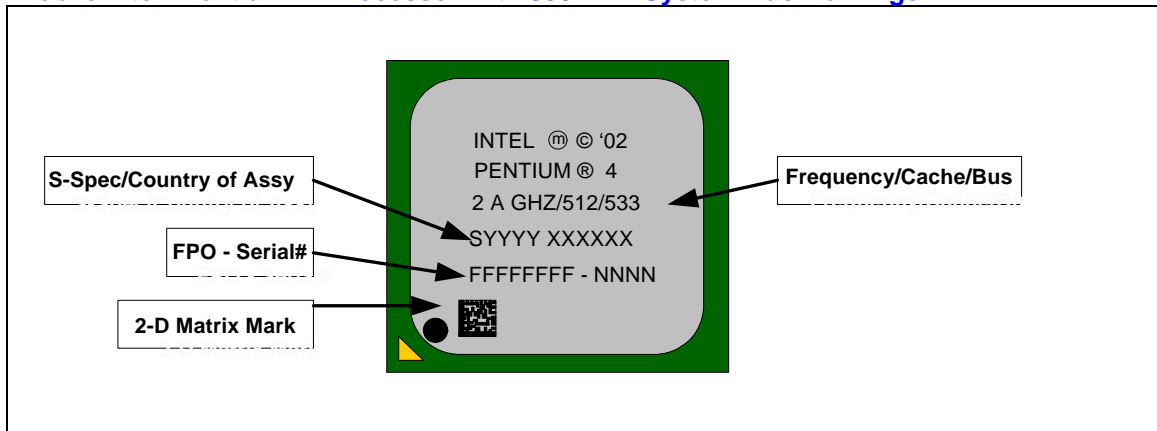
Figure 1. Mobile Intel® Pentium® 4 Processor with 533 MHz System Bus Markings

Component Marking Information
