Intel[®] Pentium[®] 4 Processor on 90 nm Process

Specification Update

September 2006

Document Number: 302352-031

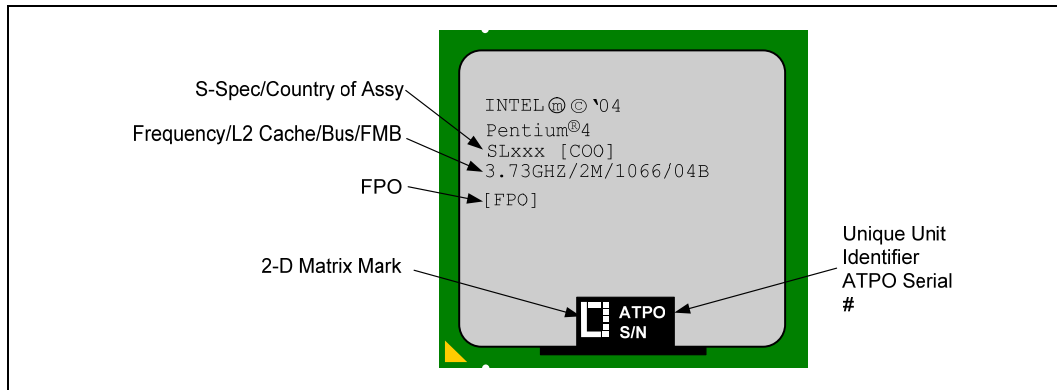
Figure 5. Intel® Pentium® 4 Processor Extreme Edition on 90 nm Process in the 775-Land LGA Package
