# Mobile Intel<sup>®</sup> 945 Express Chipset Family

**Specification Update**

***November 2009***

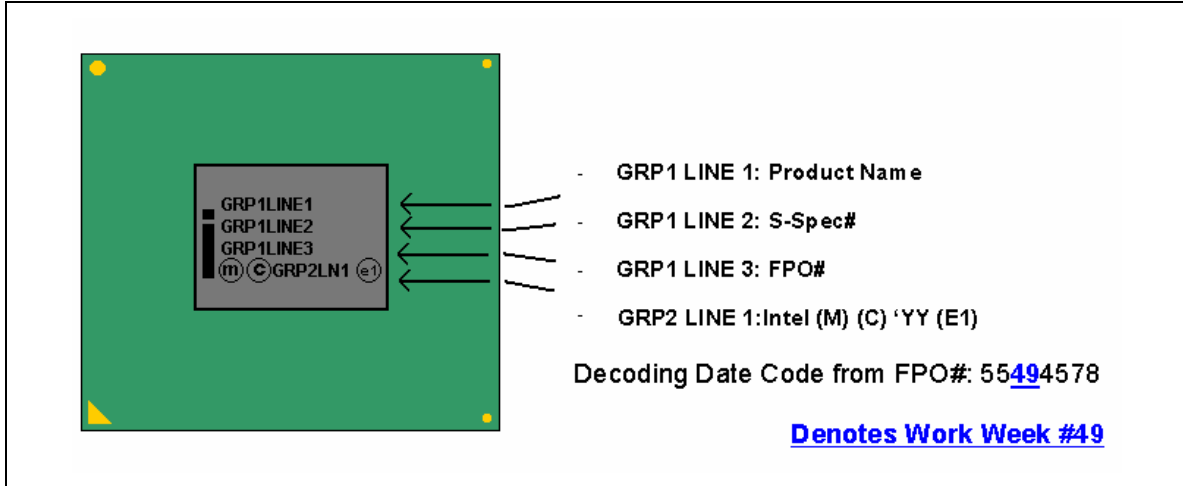
Figure 1. Mobile Intel® 945GM/GME/PM/GMS/GSE, 940GML Express Chipset and Intel® 945GT Express Chipset Lead-Free Package Markings
