Intel® Xeon® Processor 5100 Series

Specification Update

December 2010

Order Number: 313356-025

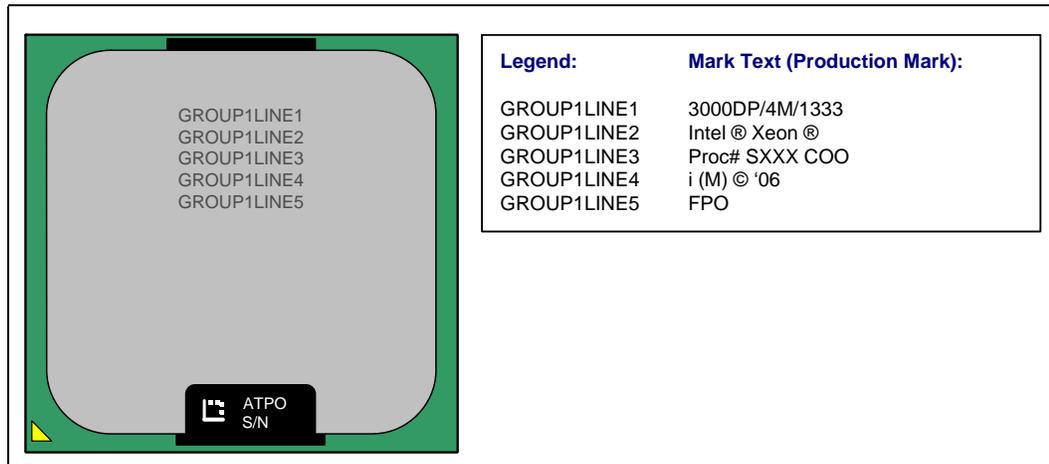
Figure 1. Processor Top-side Markings (Example)

The Intel® Xeon® Processor 5100 Series stepping can be identified by the following component markings:
