Intel[®] I/O Controller Hub 10 (ICH10) Family

Specification Update

May 2012

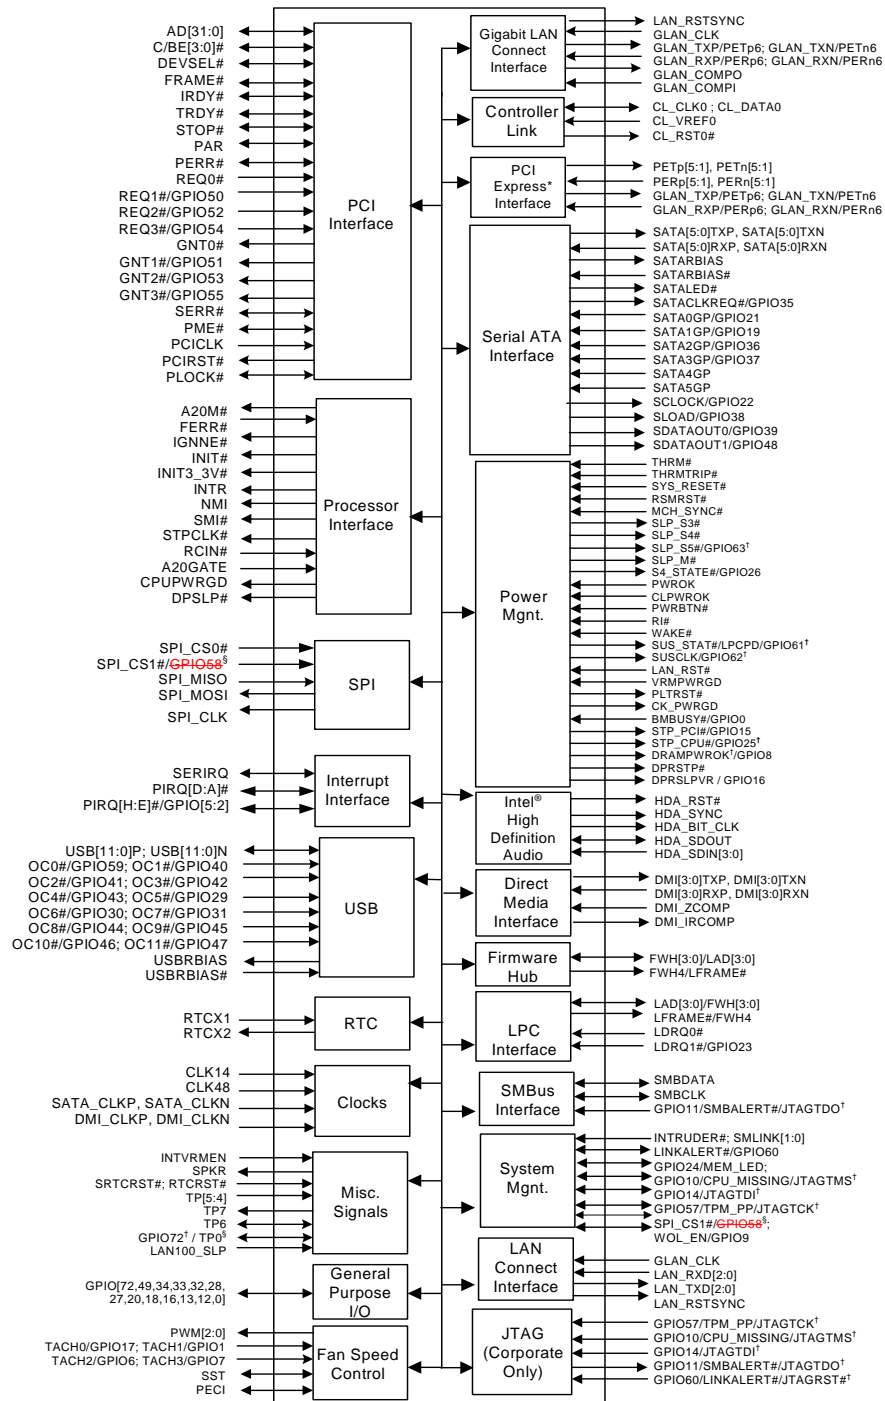
Figure 2-1. Intel® ICH10 Interface Signals Block Diagram

9. Remove GPIO58 from Figure 2-1, Intel® ICH10 Interface Signals Block Diagram
