Mobile Intel® 4 Series Express Chipset Family Graphics Memory Controller Hub (G)MCH

Specification Update

February 2010

Revision 013

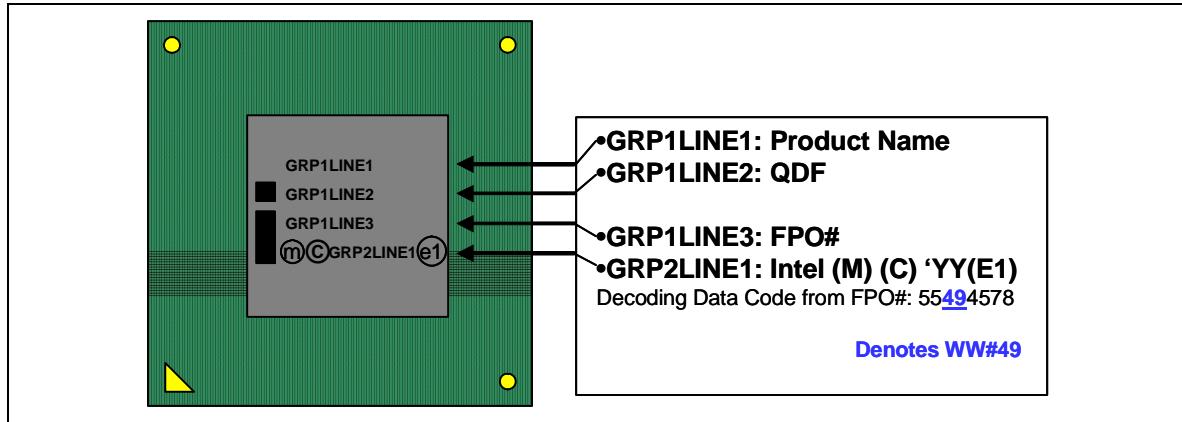
Figure 1. Mobile Intel® GM45/PM45/GL40 Express Chipset Family Graphics Memory Controller Hub (G)MCH Lead-Free Package Markings

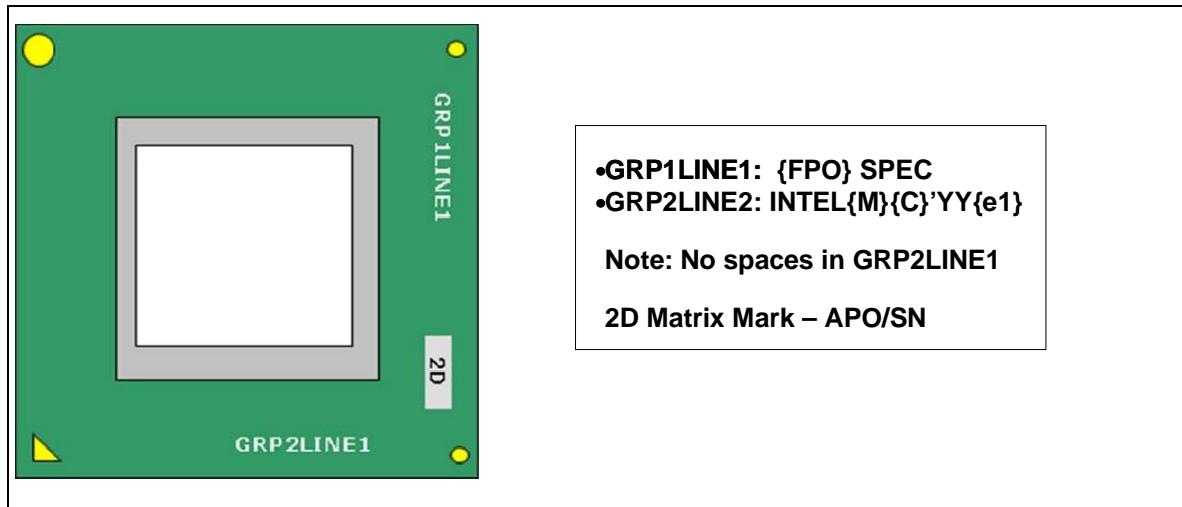
Figure 2. Mobile Intel® GS45/GS40 Express Chipset Graphics Memory Controller Hub (G)MCH Lead-Free Package Markings
