Intel[®] Celeron[®] Processor in the 478-Pin Package

Specification Update

Document Number: 290749-030

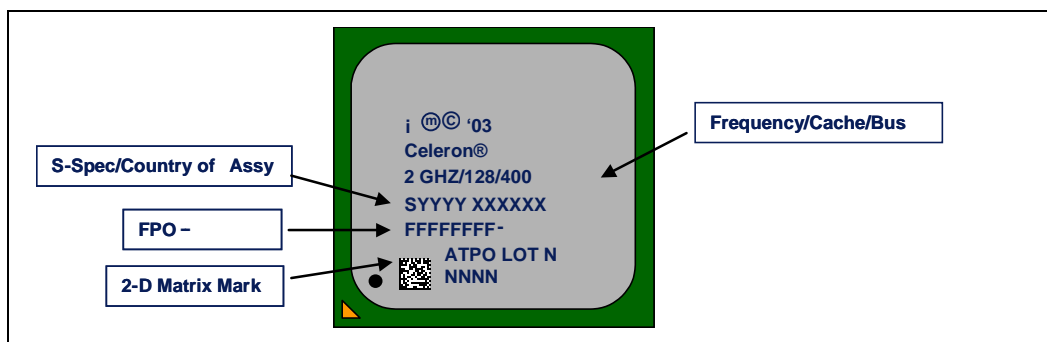
Figure 1. Example Markings for the Intel® Celeron® Processor on 0.13 Micron Process and/or in the 478-Pin Package

This section contains top marking information for the Intel® Celeron® processor in the 478-pin package.
