***Intel[®] IXP42X Product Line and
IXC1100 Control Plane
Processor: Using the Intel[®]
LXT973 Ethernet Transceiver***

Application Note

This application note presents guidelines on how to replace two Intel® LXT971A/972A Fast Ethernet Transceivers with one Intel® LXT973 Low-Power, Two-Port, Fast-Ethernet Transceiver when interfacing with a device from the Intel® IXP42X product line or with an Intel® IXC1100 Control Plane Processor. The procedure is not a totally straightforward component swap.

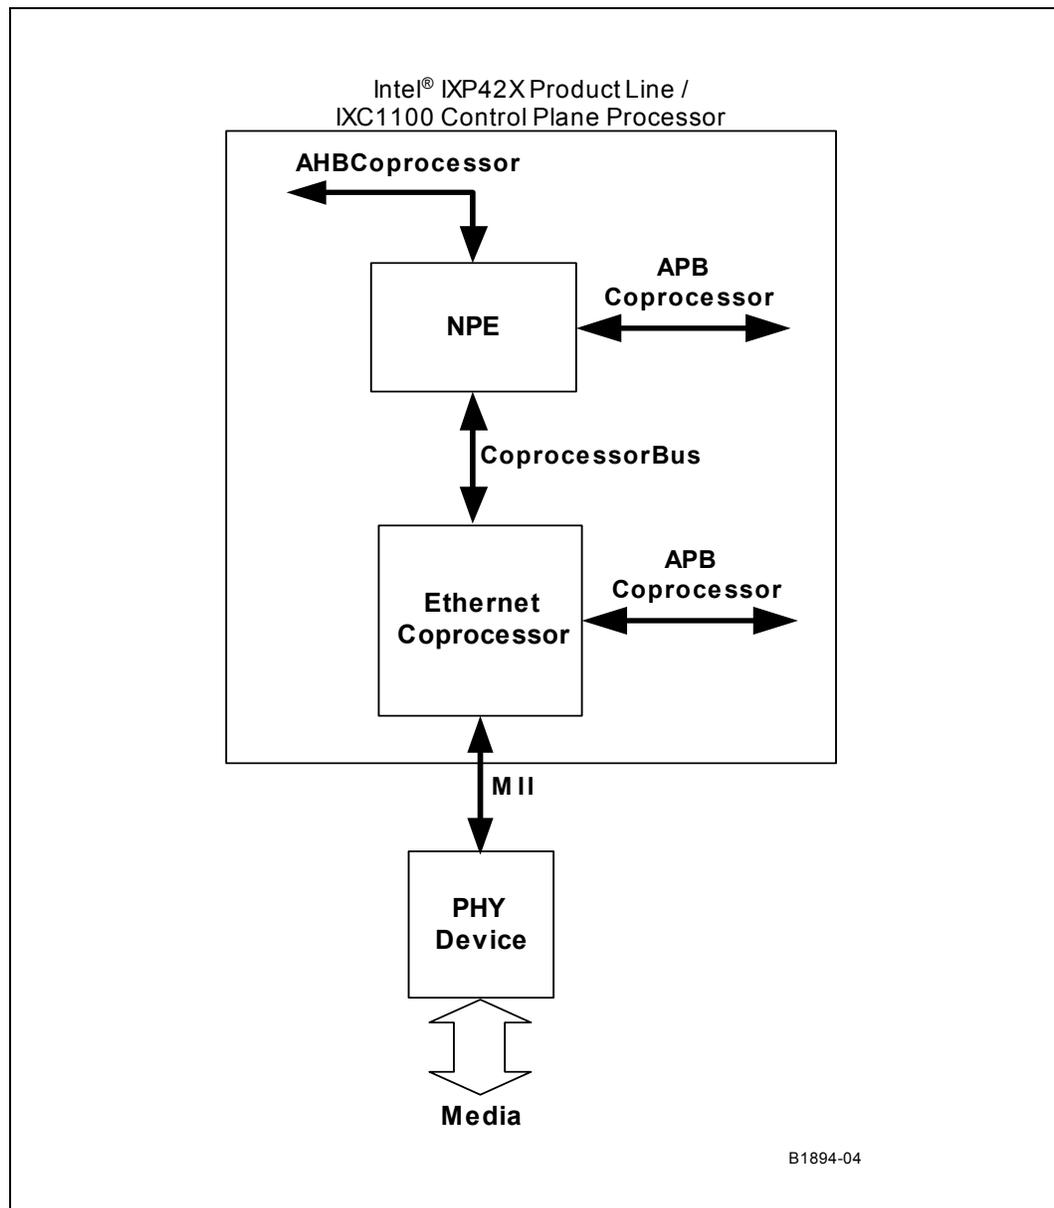
Figure 1. Ethernet System Overview

Figure 1 shows the architecture of the Ethernet implementation for Intel® IXP42X product line and IXC1100 control plane processors.
