Intel[®] Ethernet Controller X550

Specification Update

January 2016

Revision 2.0
333717-001

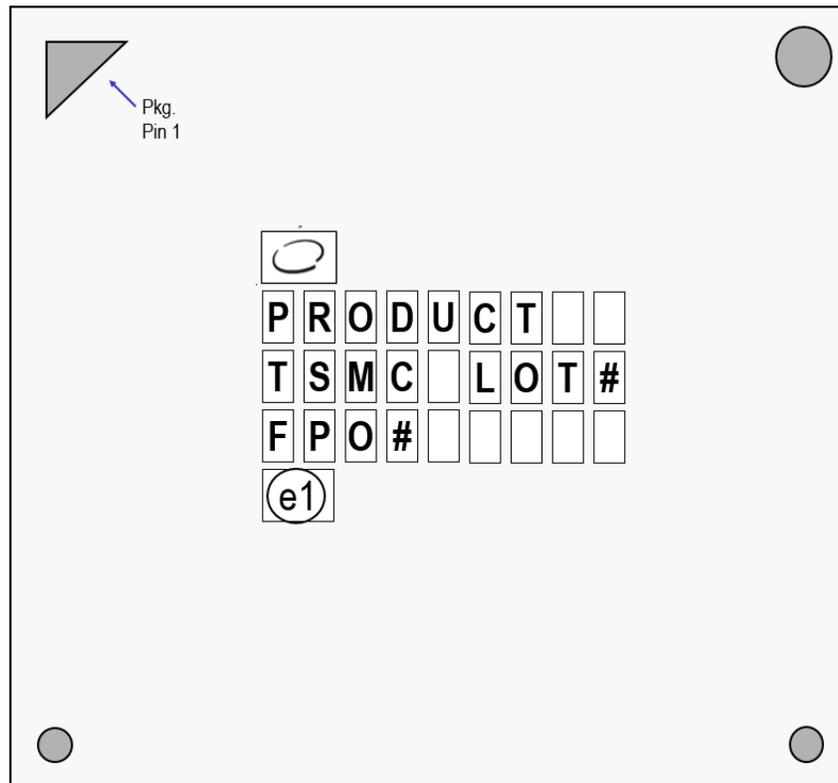
Figure 1-1 X550-AT2

- LINE1: Swirl Logo
- LINE2: Product code
- LINE3: TSMC LOT#
- LINE4: FPO# Trace code
- LINE5: Pb-free mark

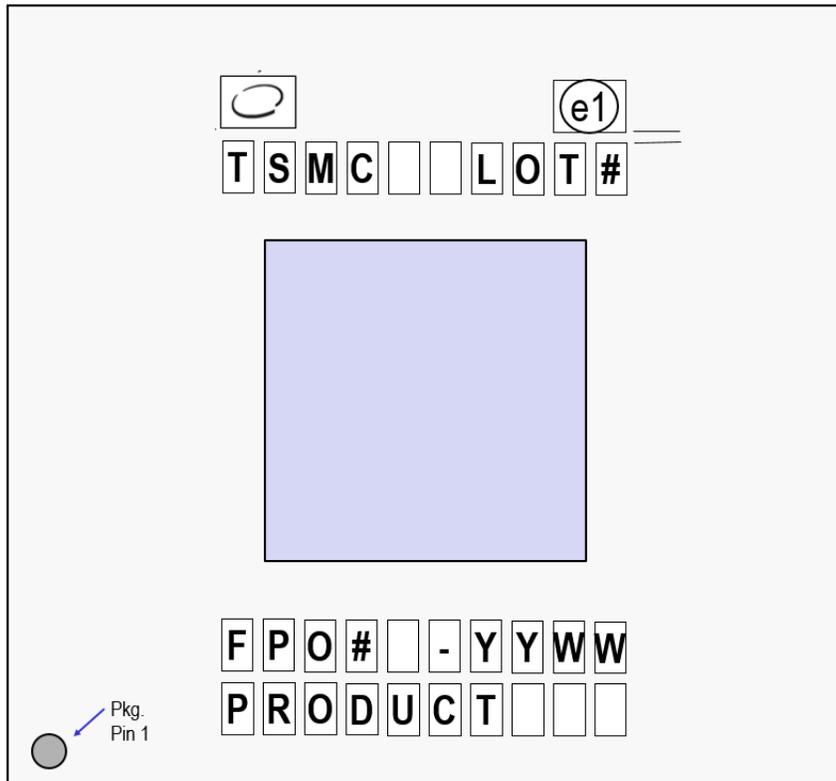
Figure 1-2 X550-BT2

- GRP1LINE1: Swirl Logo, Pb-Free
- GRP1 LINE2: TSMC Lot#
- GRP2LINE1: FPO# YYWW
- GRP2LINE2: Product Code
