Second Generation Intel® Xeon® Scalable Processors

Specification Update

May 2019

Reference Number: 338848-003US

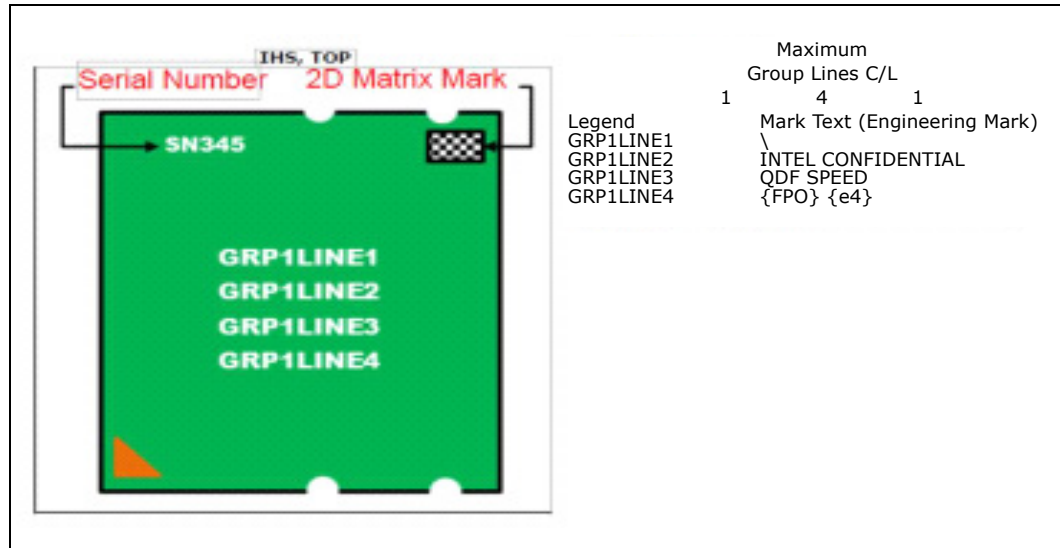
Figure 10. Processor Preliminary Top Side Marking (Example)

Component Marking Information
