Intel® Core™ i7 Processor Family for LGA2011 Socket

Specification Update

Supporting Desktop Intel® Core™ i7-4960X Extreme Edition Processor Series for the LGA2011 Socket

Supporting Desktop Intel® Core™ i7-49xx and i7-48xx Processor Series for the LGA2011 Socket

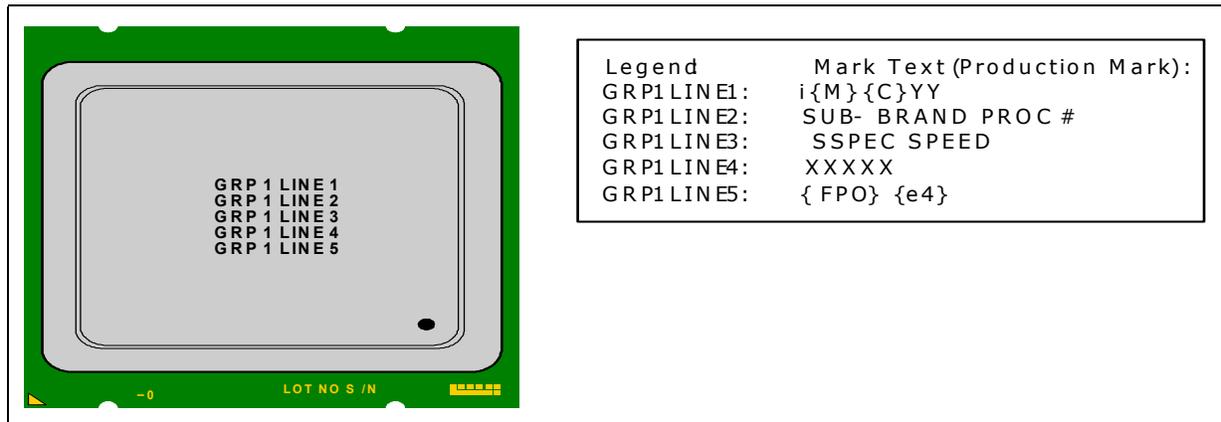
Figure 1. Processor Top-side Markings (example)

The processor stepping can be identified by the following component markings:
