# Intel<sup>®</sup> 5520 and Intel<sup>®</sup> 5500 Chipset

## Specification Update

*February 2015*

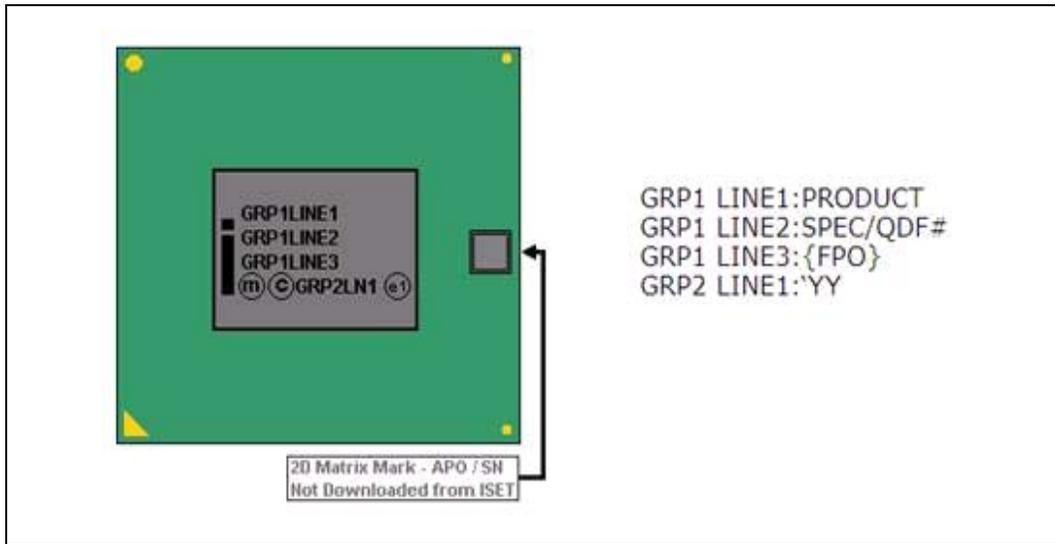
Figure 1. Top-Side Marking Example

1. This is an Engineering Sample
2. This is a Production part
3. This part has 24 PCIe\* lanes
4. This part has 36 PCIe lanes
5. This part supports Intel® Trusted Execution Technology (Intel® TXT)
