# **Intel<sup>®</sup> 82599 10 GbE Controller**

**Specification Update**

Revision 3.7  
331521-006

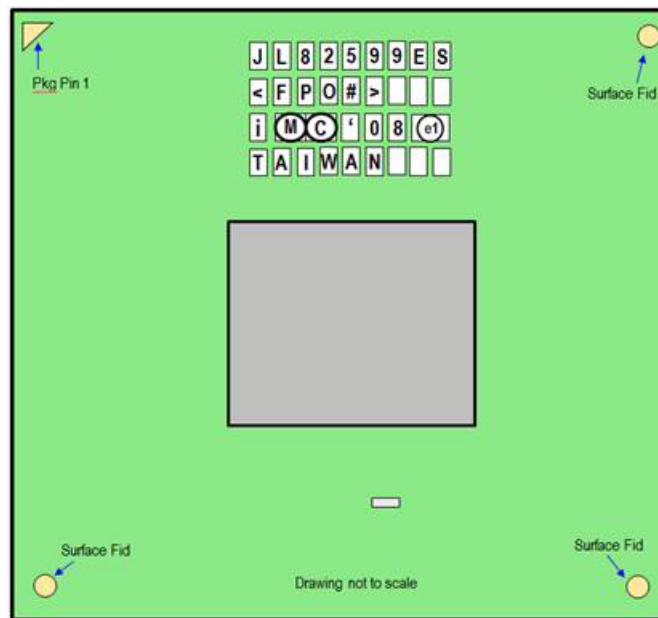
**Figure 1-1 Example with Identifying Marks**

Lead-free parts will have "JL" as the prefix for the product code.

The "S" designator refers to the specification number. See [Table 1-1](#).

3.2	November 14, 2014	<b>Specification Clarifications added or updated:</b> <ul style="list-style-type: none"><li>17. CRCERRS Statistic Counter (Added)</li></ul> <b>Specification Changes added or updated:</b> <ul style="list-style-type: none"><li>10. ETQF[19:16] are Reserved (Added)</li></ul> <b>Errata added or updated:</b> <ul style="list-style-type: none"><li>64. PCIe SR-IOV Reserved Bits are Writable (Added)</li></ul> <b>Miscellaneous Updates:</b> <ul style="list-style-type: none"><li>Section 1.2, "Marking Diagrams" — Text added in reference to Figure 1-1 to explain the meaning of the dash mark (-) in the illustration.</li></ul>

3.1	March 27, 2014	<b>Miscellaneous Updates:</b> <ul style="list-style-type: none"><li>Marking Diagram in Figure 1-1 updated to reflect new substrate.</li></ul>
