Intel® Atom™ Processor N2000 and D2000 Series

Specification Update

May 2013

Revision 013

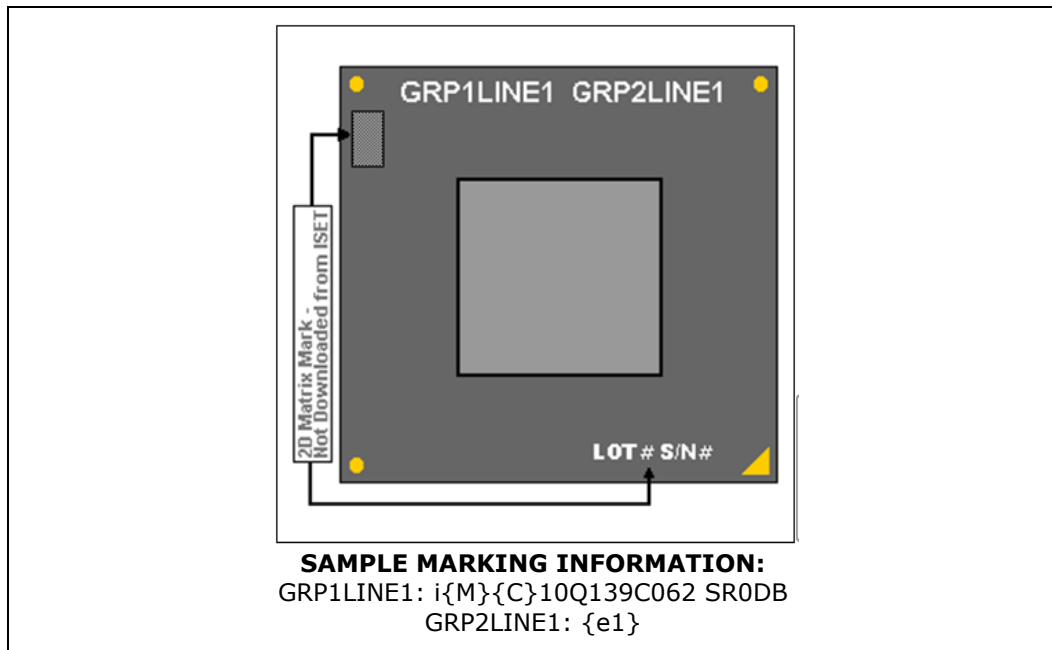
Figure 1: Intel® Atom™ Processor N2000 and D2000 Series (Micro-FCBGA11) Markings

Intel® Atom™ Processor N2000 and D2000 series is identified by the following component markings.
