Intel Atom[®] Processor E3800

Specification Update

(Formerly Bay Trail -I SoC)

May 2018

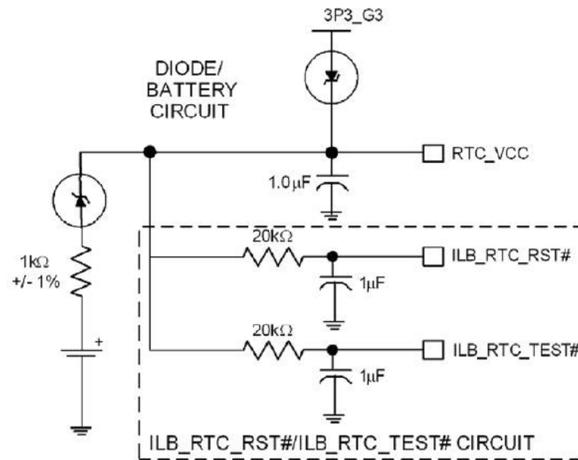
2. ILB_RTC_TEST# and ILB_RTC_RST# RC Time Delay Calculation Formula

The RC delay between RTC_VCC to ILB_RTC_TEST and ILB_RTC_RTC, Figure 21-4 in Section 21.2.3 of the PDG (Doc ID #512379) is obtained by using the formula $t = -\ln((RTC_VCC - V_{ih\ min})/RTC_VCC) * R * C$ and the added circuit is as follows:

The SoC RTC requires some additional external circuitry. The ILB_RTC_RST# and ILB_RTC_TEST# signals are used to reset the RTC well. The external capacitor and the external resistor between ILB_RTC_RST#/ILB_RTC_TEST# and RTC battery (VBAT) were selected to create an RC time delay, such that ILB_RTC_RST# and ILB_RTC_TEST# go high sometime after the battery voltage is valid. The RC time delay should be in the range of 18-25 ms. When ILB_RTC_TEST# is asserted, bit 2 (RTC_PWR_STS) in the GEN_PMCON_1 (General PM Configuration 1) register is set to 1, and remains set until software clears it. Hence, when the system boots, the BIOS recognizes that the RTC battery is removed.
