Intel® Atom™ Processor Z2760

Specification Update

November 2013

Revision 003

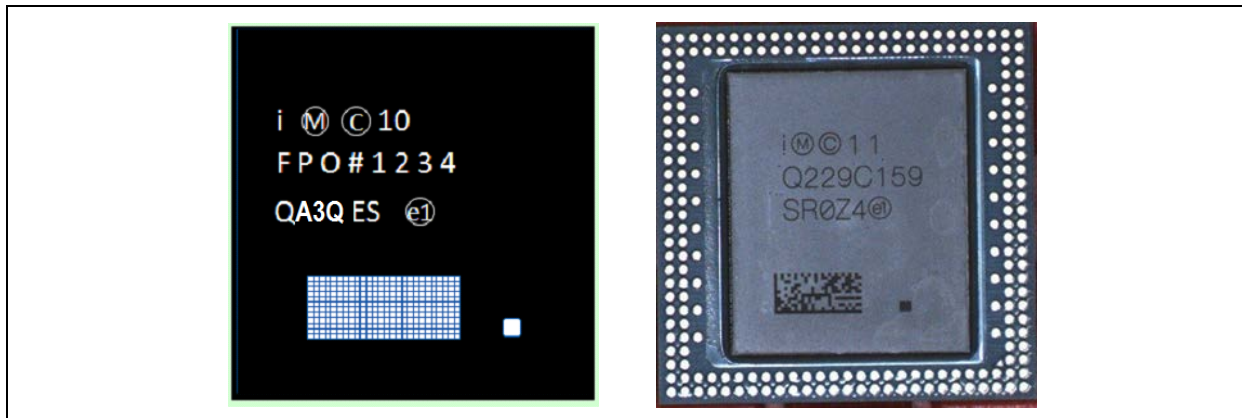
Figure 1. Intel® Atom™ Processor Z2760 Component Marking Information

Processor shipments can be identified by the following component markings and example pictures.

NOTE: Package Marking Legend

1. LINE 1 - INTEL TM C '10 (trademark, copyright information, year assy.)
2. LINE 2 - FPO# (Fab Lot number)
3. LINE 3 - e1 (RoHS indicator)
4. BOTTOM -2DID (Barcode information assy. lot code), Pin 1 indicator
