Intel[®] Atom[™] Processor Z600 Series

Specification Update

For the Intel[®] Atom[™] Processor Z670 on 45-nm Process Technology

Revision 005

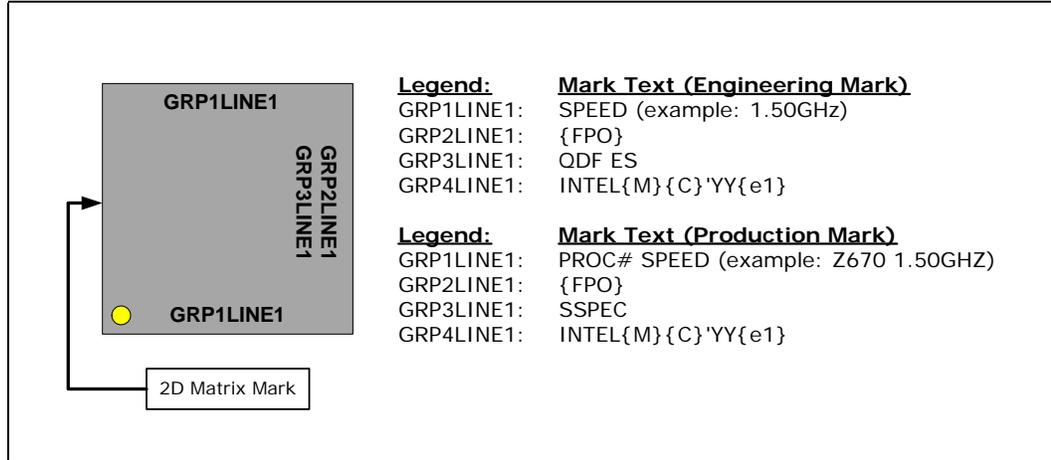
Figure 1-1. Processor Top-side Markings (Example)

The processor stepping can be identified by the following component markings:
