Intel® Core™2 Extreme Processor QX9000^Δ Series and Intel® Core™2 Quad Processor Q9000^Δ, Q9000S^Δ, Q8000^Δ and Q8000S^Δ Series

Specification Update

— on 45 nm Process in the 775-land LGA Package

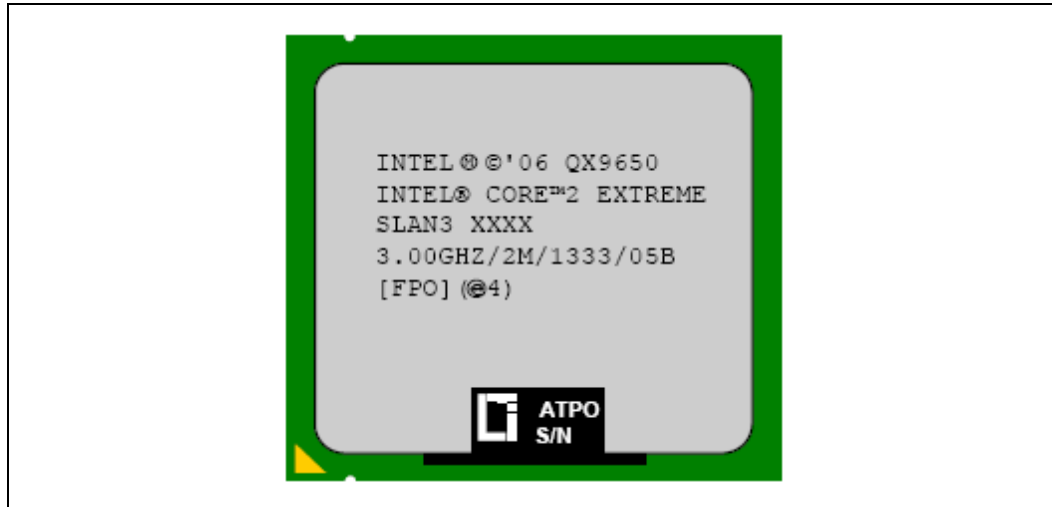
Figure 1. Processor Top-Side Markings Example (Intel® Core™2 Extreme Processor QX9650)
