# Intel<sup>®</sup> Core<sup>™</sup> i7-900 Desktop Processor Extreme Edition Series and Intel<sup>®</sup> Core<sup>™</sup> i7-900 Desktop Processor Series

Specification Update

Revision 037

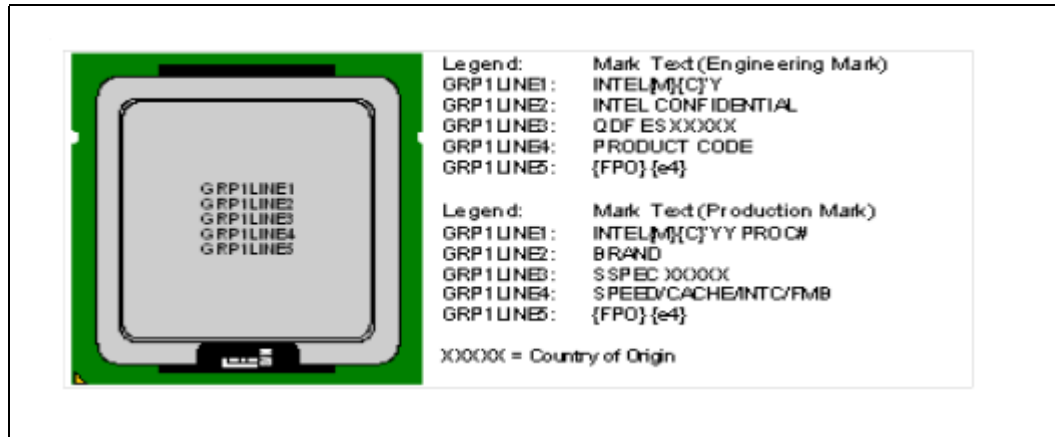
Figure 1. Processor Top-side Markings (Example)

The Intel® Core™ i7 processor Extreme Edition and Intel® Core™ i7 processor stepping can be identified by the following component markings:
