Intel[®] Ethernet Controller X540

Specification Update

July 2017

Revision 3.3
334566-002

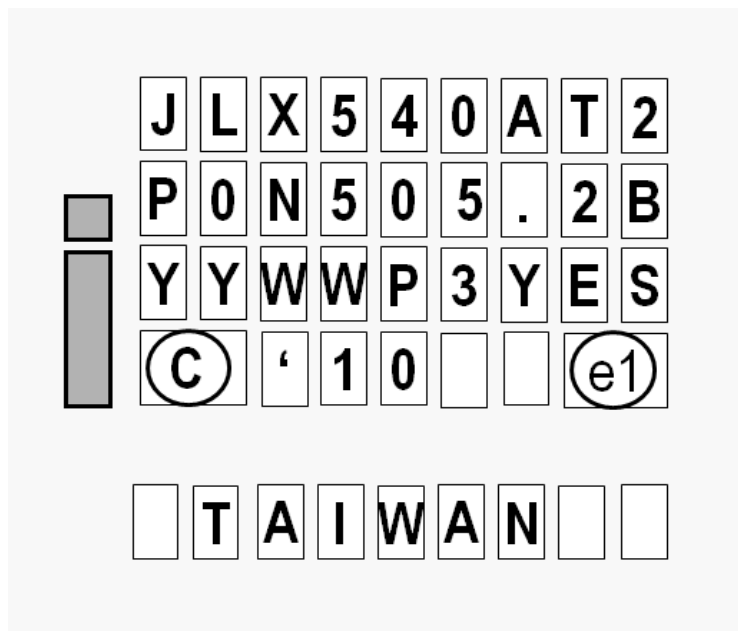
Figure 1-1 Example with Identifying Marks

- LINE1: Product code
- LINE2: Wafer lot# concatenated with Assembler vendor code
- LINE3: Assy YYWW followed by Q-spec# (no "Q") and ES for Engineering Sample
- LINE4: Copyright, ' YY, Pb-free mark
- LINE5: Country of origin (COO)
