# **Intel<sup>®</sup> Ethernet Controller I210**

**Specification Update**

**Ethernet Networking Division (ND)**

Revision 2.5  
332763-009

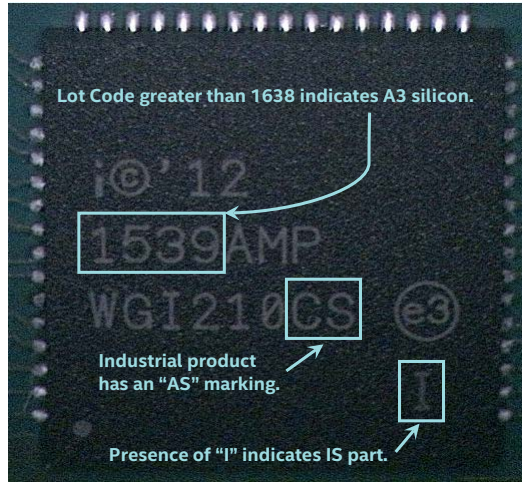
Figure 1-1 Explanation of Top Markings for A3 Stepping

- Fab Lot Trace Codes starting with 1638 or greater are A3 devices.
- Bit 1 of INVM\_DATA[61] (0x12214) is 1b on A3 devices.

Figure 1-1 shows an example:

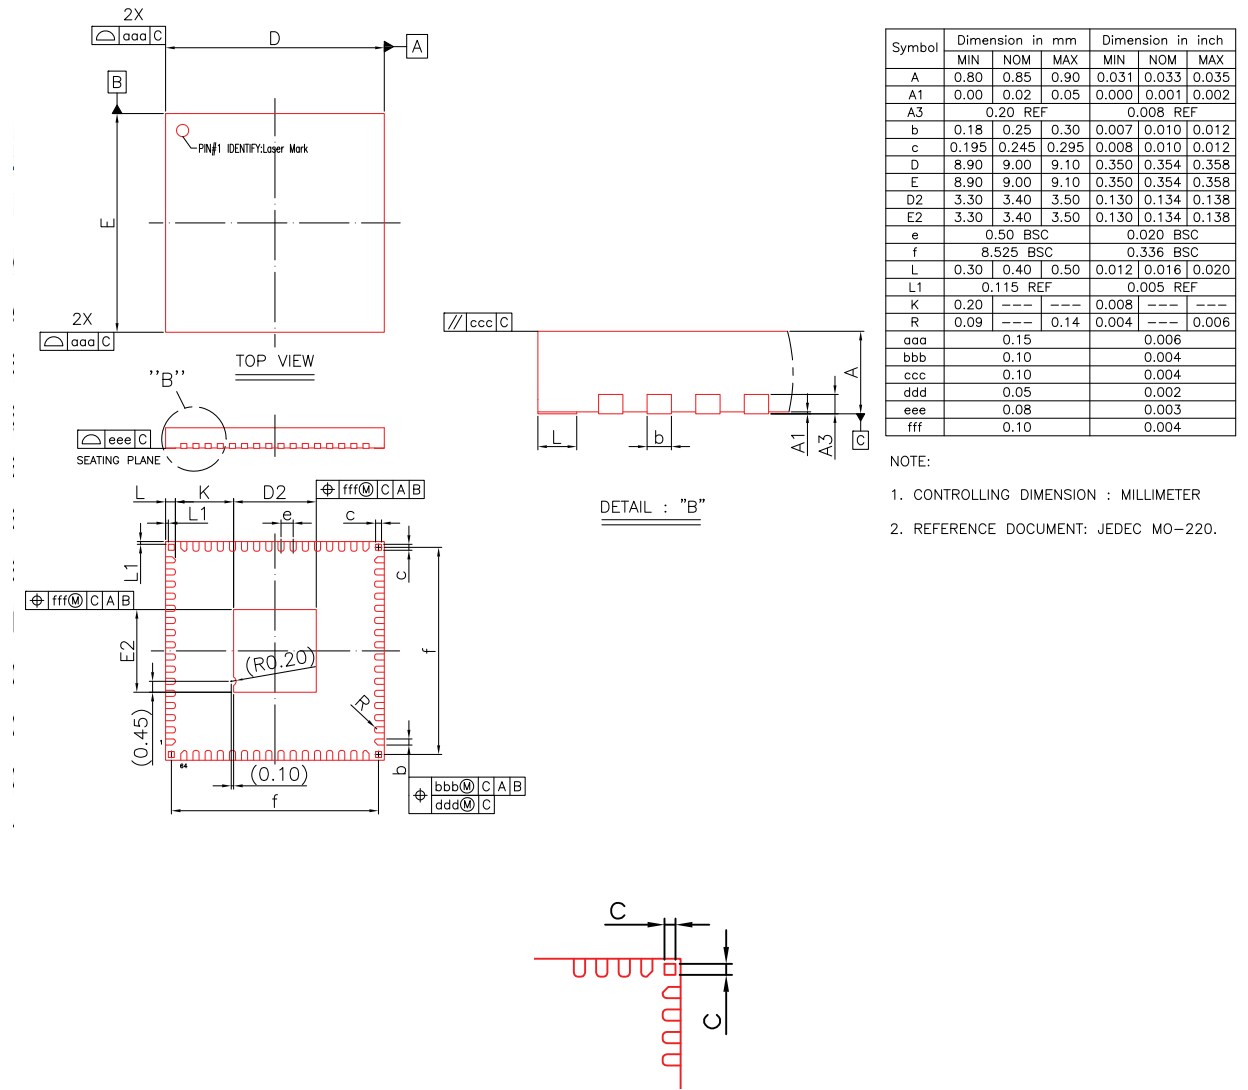
## 7. WGI210CS Automotive Industrial Temperature Fiber Schematic

**Note:** The I210 CS has four no-connect corner pads for added solder joint reliability (as shown in Detail C).
