# **Intel<sup>®</sup> Ethernet Controller I210**

**Specification Update**

Revision 2.3  
332763-007

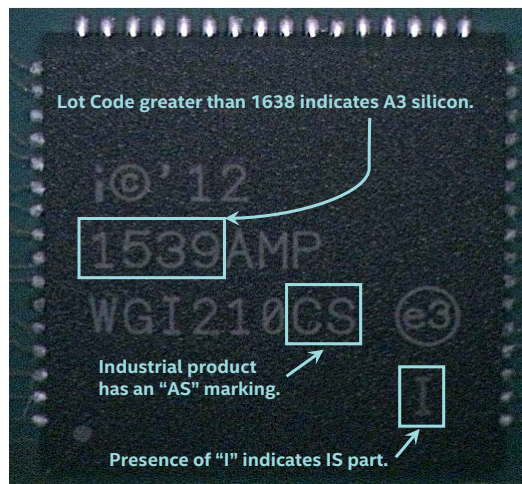
**Figure 1-1 Explanation of Top Markings for A3 Stepping**

- Fab Lot Trace Codes starting with 1638 or greater are A3 devices.
- Bit 1 of INVM\_DATA[61] (0x12214) is 1b on A3 devices.

Figure 1-1 shows an example:
