Intel[®] Ethernet Controller I210

Specification Update

Revision 2.4
332763-008

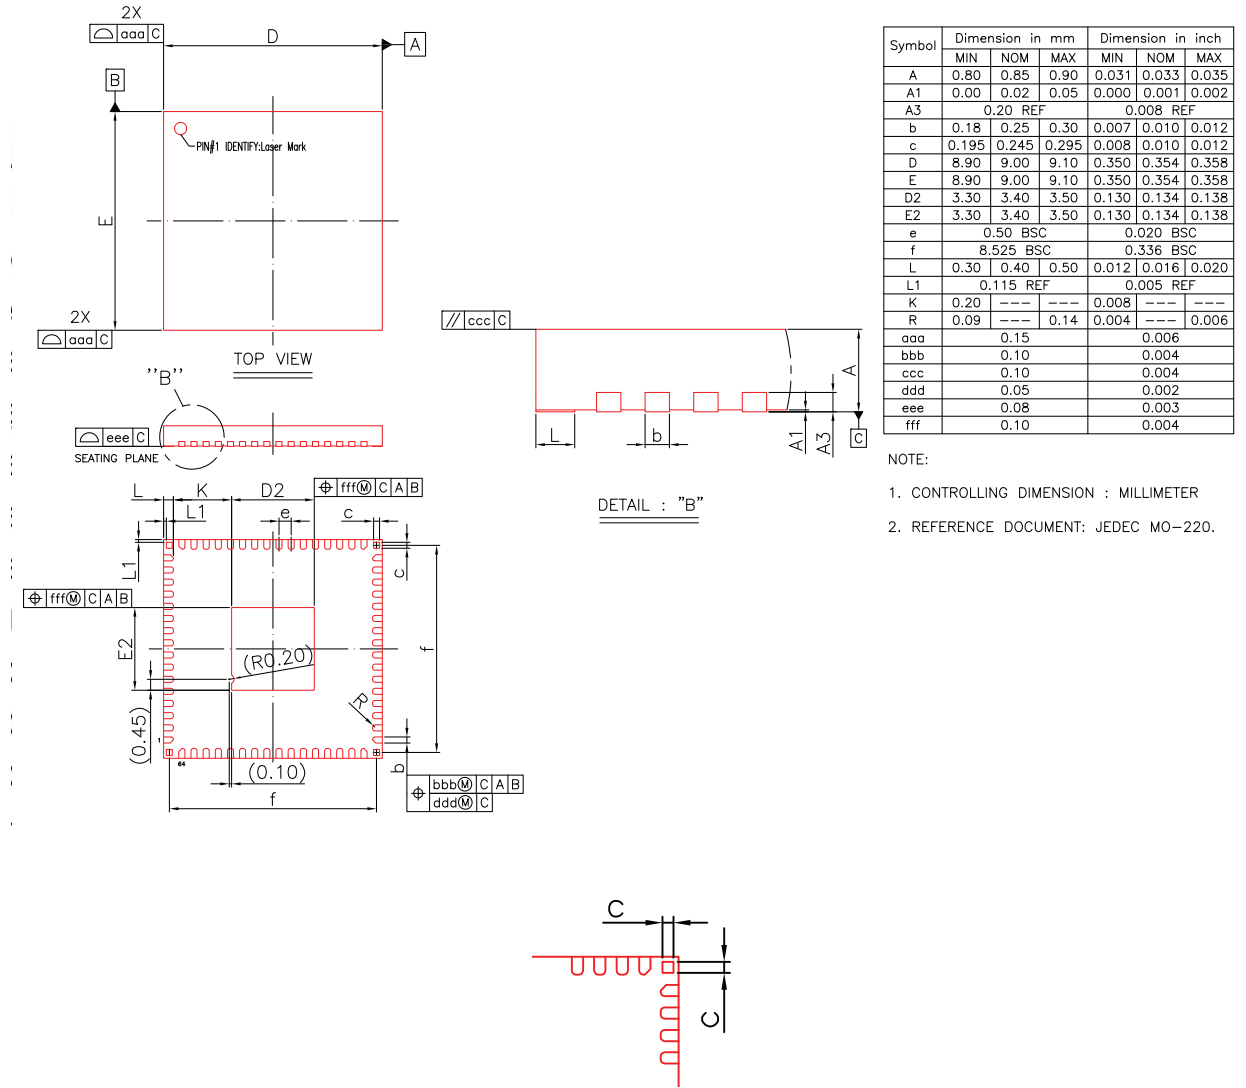
7. WGI210CS Automotive Industrial Temperature Fiber Schematic

Note: The I210 CS has four no-connect corner pads for added solder joint reliability (as shown in Detail C).
