Intel® Pentium® and Celeron® Processor N- and J- Series

Specification Update

October 2018

Revision 007

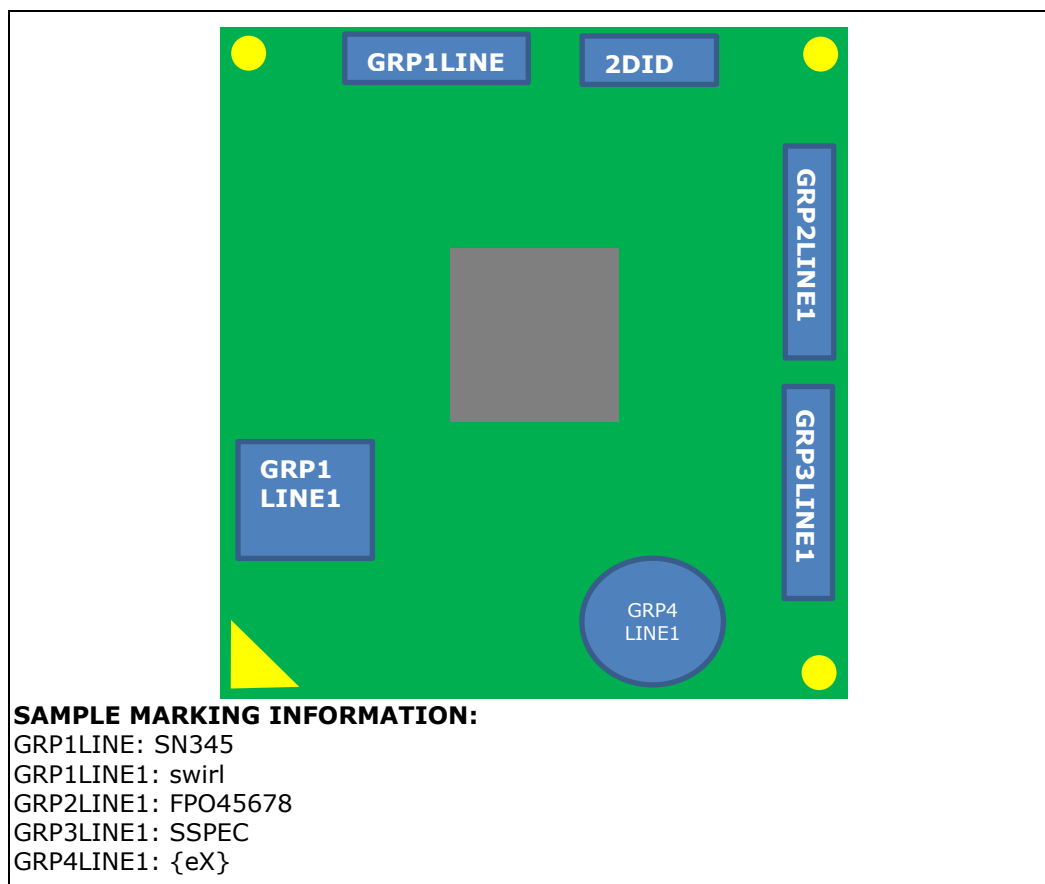
Figure 1. Processor Family Top-Side Markings

Processor shipments can be identified by the following component markings and example pictures.
