# **N-series Intel<sup>®</sup> Pentium<sup>®</sup> Processors and Intel<sup>®</sup> Celeron<sup>®</sup> Processors**

**Specification Update**

*Revision 016*

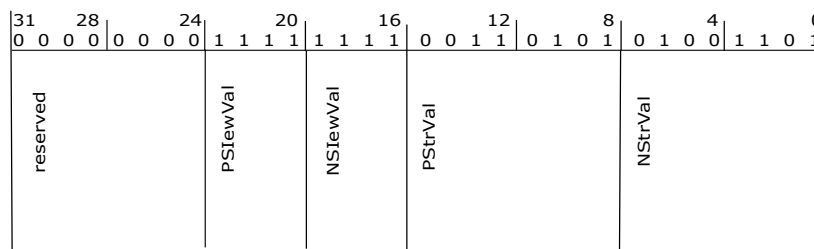
**Op Codes:** 06h - Read, 07h - Write

**Default:** 00FF354Dh

Bit range	Default and Access	Field Name (ID): Description
23:20 <sup>1</sup>	0xf RO	P Slew Value (PSlewVal): P Slew values. Valid only after calibration is done.
19:16 <sup>2</sup>	0xf RO	N Slew Value (NSlewVal): N Slew Value. Valid only after calibration is done.

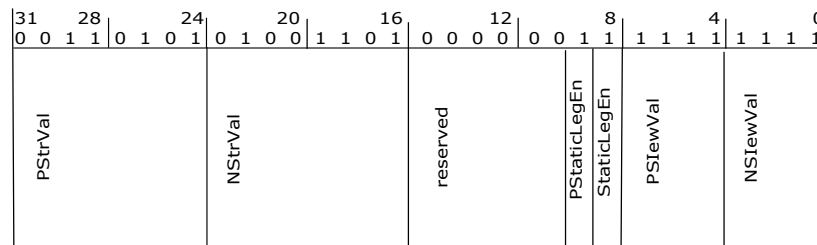
**Op Codes:** 06h - Read, 07h - Write

**Default:** 354D03FFh

Bit range	Default and Access	Field Name (ID): Description
7:4 <sup>1</sup>	0xf RW	P Slew Value (PSlewVal): P Slew values for Pull-up settings.
3:0 <sup>2</sup>	0xf RW	N Slew Value (NSlewVal): N Slew Values for Pull-down settings.

- Note:*
1. For LPC IO family, bits [5:4] are used to configure the PSlewVal, and bits [7:6] are reserved.
  2. For LPC IO family, bits [1:0] are used to configure the NSlewVal and bits [3:2] are reserved.

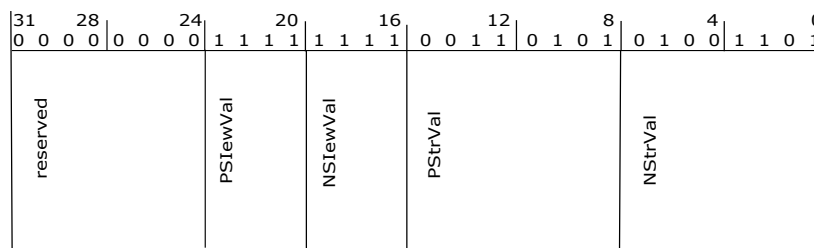
**Op Codes:** 06h - Read, 07h - Write

**Default:** 00FF354Dhs
