N-series Intel[®] Pentium[®] Processors and Intel[®] Celeron[®] Processors

Specification Update

May 2018

Revision 015

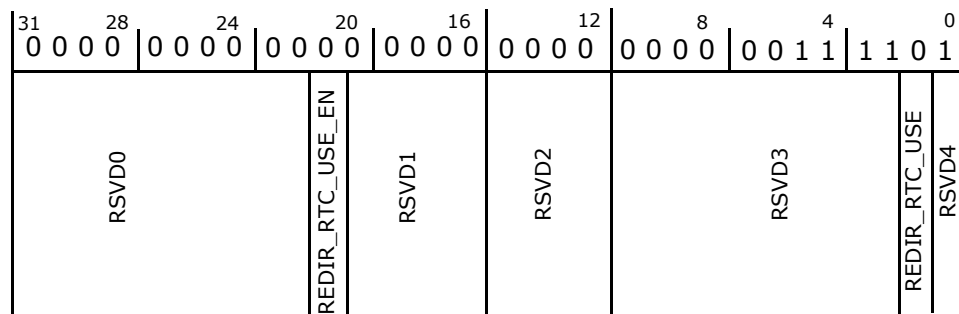
ILB_BASE_ADDRESS Reference: [B:0, D:31, F:0] + 50h

Default: 0000003Dh

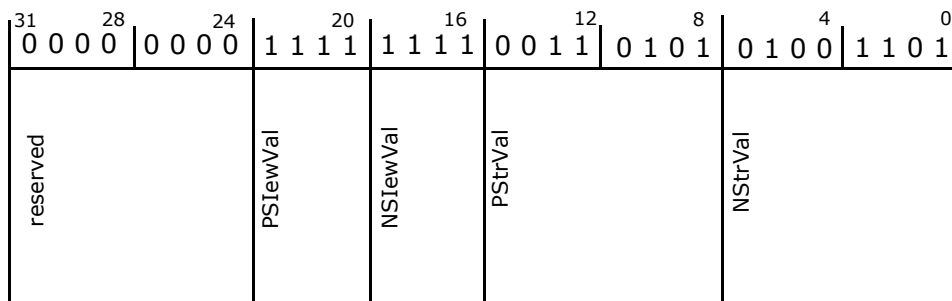
Default: 00FF354Dh

Bit Range	Default and Access	Field Name (ID): Description
23:20 ¹	0xf RO	P Slew Value (PSIewVal); P Slew values. Valid only after calibration is done.
19:16 ²	0xf RO	N Slew Value (NSIewVal); N Slew Value. Valid only after calibration is done.

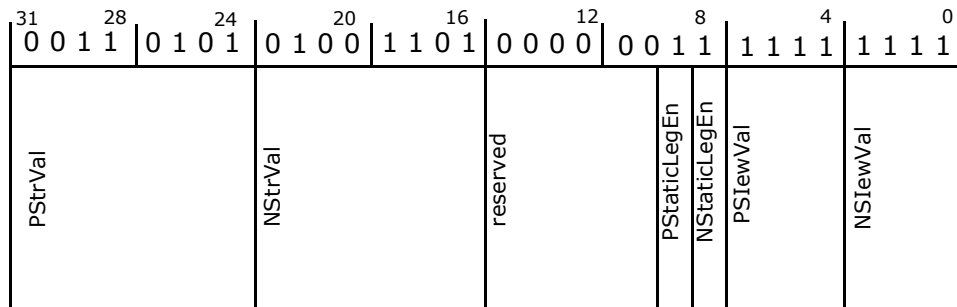
Default: 354D03FFh

Bit Range	Default and Access	Field Name (ID): Description
7:4 ¹	0xf RW	P Slew Value (PSIewVal): P Slew values for Pull-up settings.
3:0 ²	0xf RW	N Slew Value (NSIewVal): N Slew values for Pull-down settings.

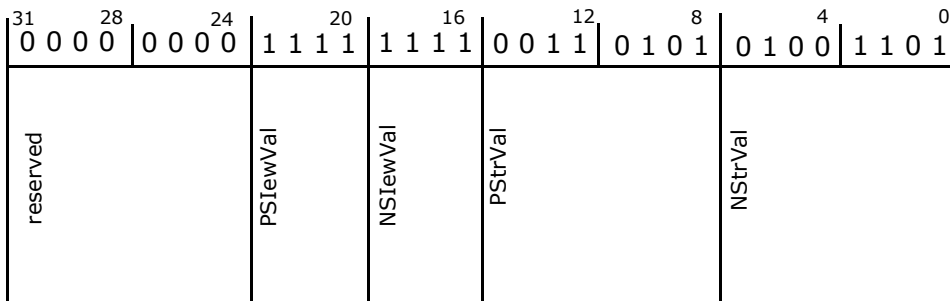
Default: 00FF354Dhs

Bit Range	Default and Access	Field Name (ID): Description
23:20 ¹	0xf RO	P Slew Value (PSIewVal): P Slew values. Valid only after calibration is done.
19:16 ²	0xf RO	N Slew Value (NSIewVal): N Slew Value. Valid only after calibration is done.
