Intel® Pentium® Dual-Core Processor

Specification Update

December 2010

Revision 010

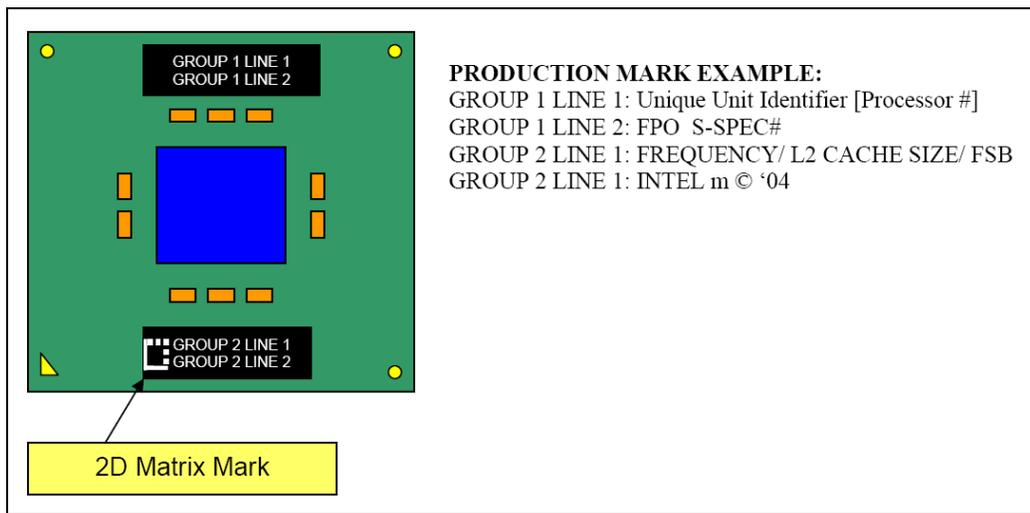
Figure 1. Intel® Pentium® Dual-Core Mobile Processor on 65-nm Process (Micro-FCPGA/FCBGA) S-Spec Markings
