Intel® Xeon® Processor 5400 Series

Specification Update

August 2013

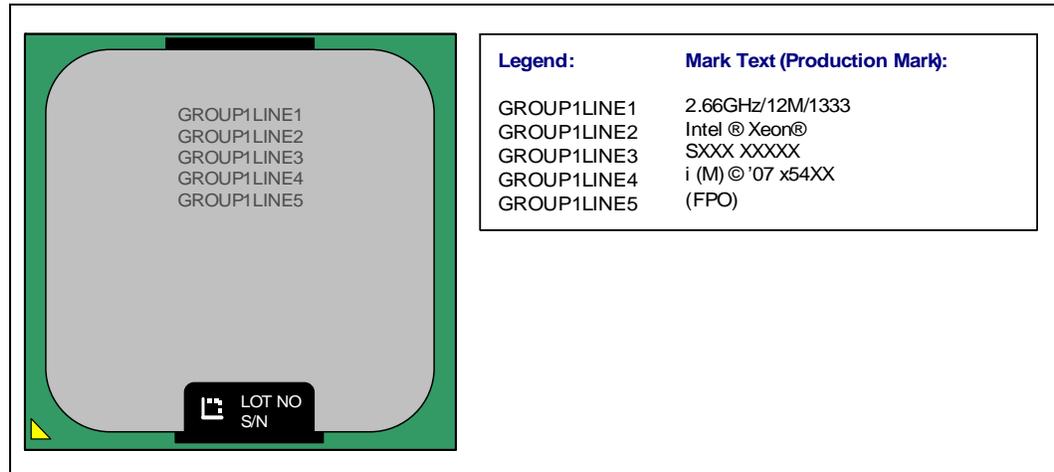
Figure 1. Processor Top-side Markings (Example)

Intel® Xeon® Processor 5400 Series stepping can be identified by the following component markings:
