Intel® Xeon® E3-1125C v2, E3-1105C v2, Intel® Core™ 3115C and Intel® Pentium® Processor B925C

Specification Update

July 2015

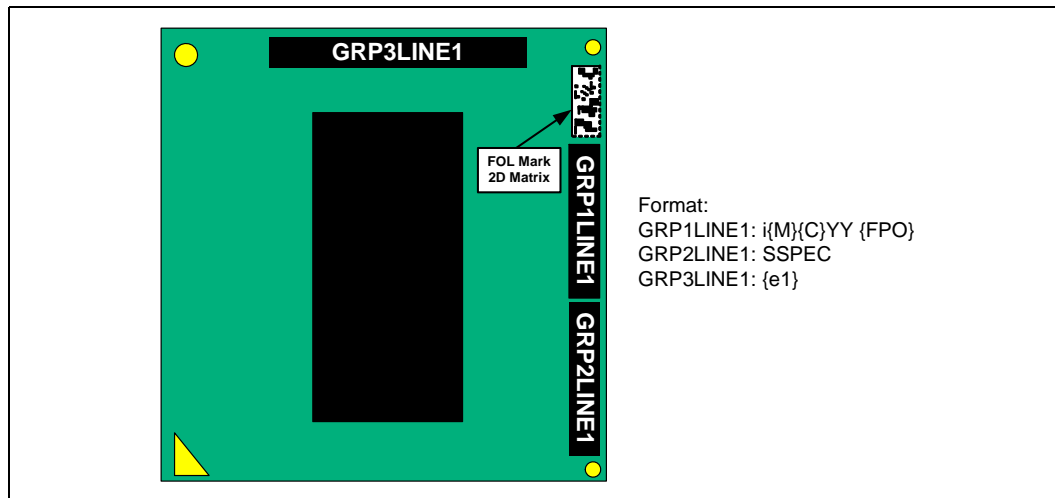
Figure 1. Component Markings

The processor stepping can be identified by the component markings in Figure 1.

The Processor Identification table below lists the “S-Spec” component marking numbers of production parts, along with some additional SKU details.
