Intel[®] Xeon[®] E3-1200 Processor Product Family

Specification Update

February 2020

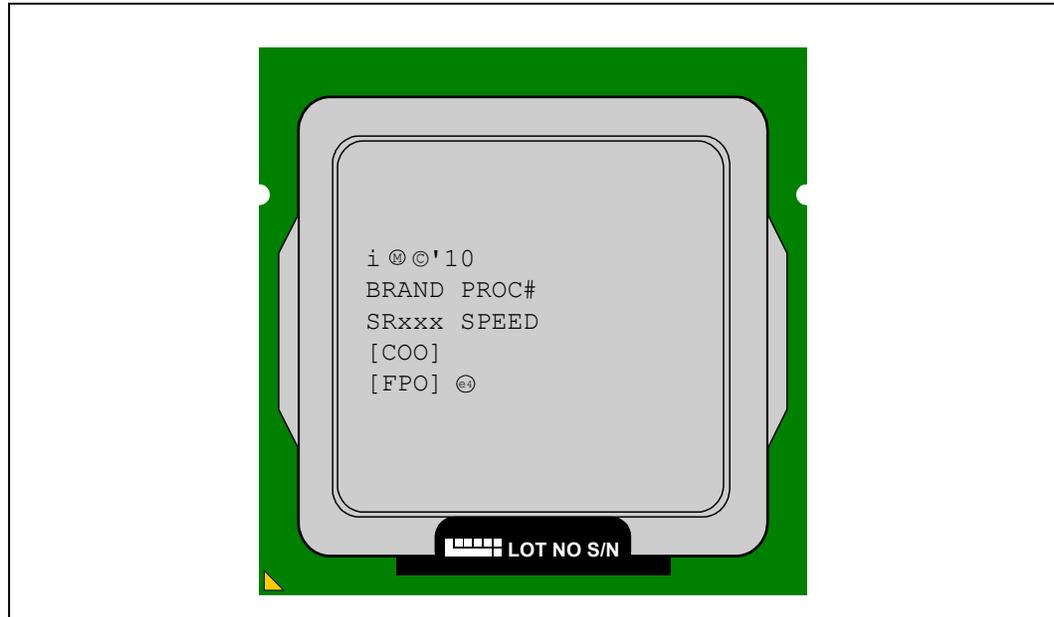
Figure 1. Processor Production Top-side Markings (Example)

The processor stepping can be identified by the following component markings.
