Intel[®] Xeon[®] Processor E7 v2 Product Family

Specification Update

September 2017

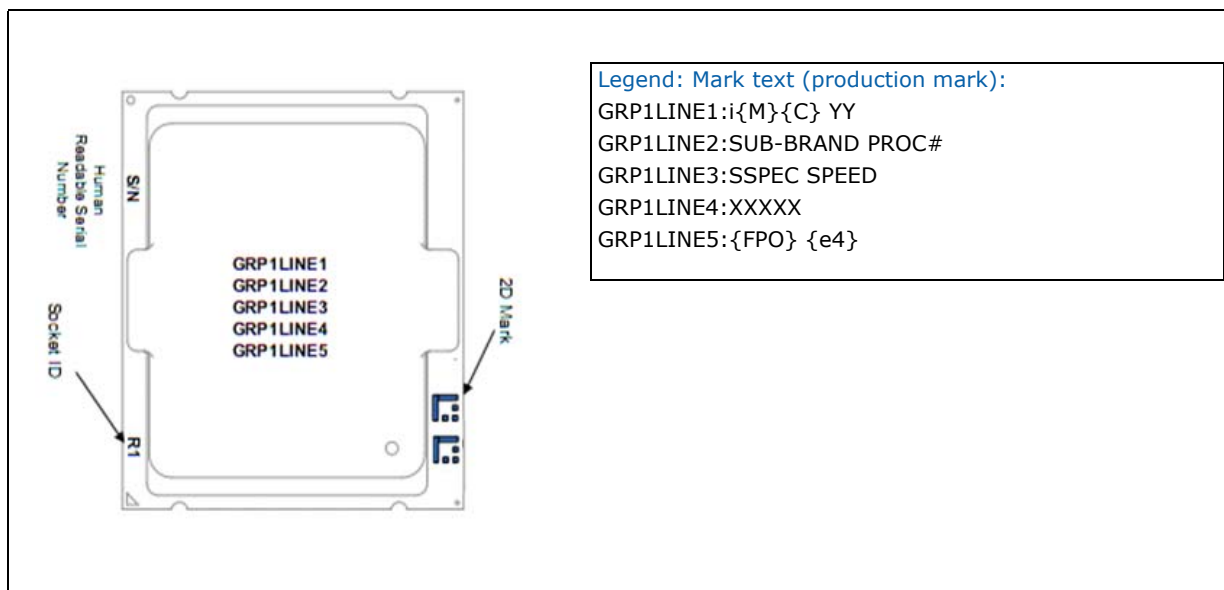
The Intel® Xeon® Processor E7 v2 Product Family can be identified by the following component markings:

Figure 1. Processor top-side marking (example)
