Intel[®] Ethernet Controller X710/ XXV710/XL710

Specification Update

November 2018

Revision 3.5
331430-015

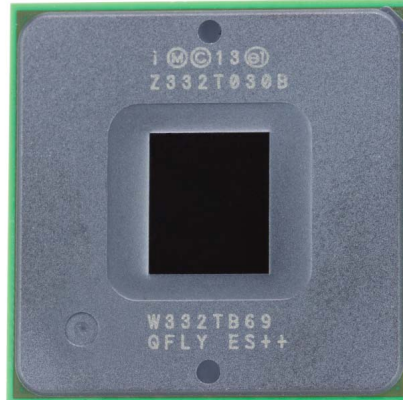
Figure 1-1 Example Component with Identifying Marks
